National Property Inspections

Bettner Trust, 3421 Santa Clara Cir, Costa Mesa, CA, 92626

Wednesday, November 5, 2025

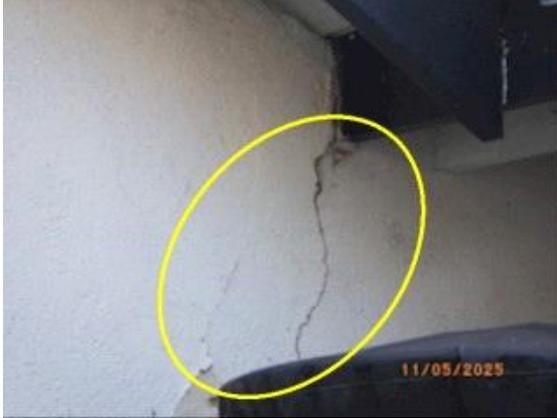
"Settlement" related conditions suspected

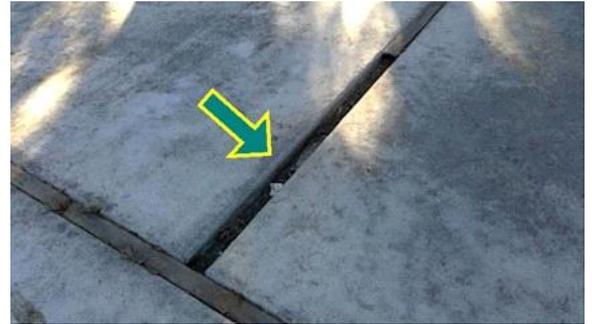
Decayed / missing expansion joints - Tripping hazard

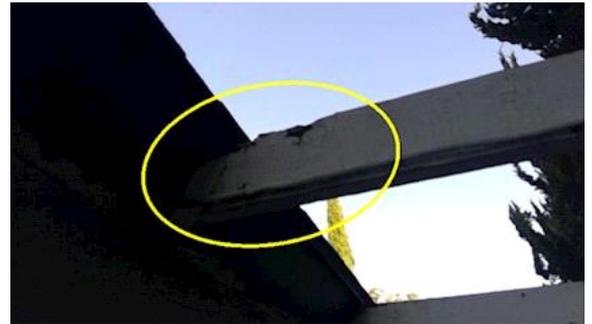
Wood rot / decay @ structural assemblies

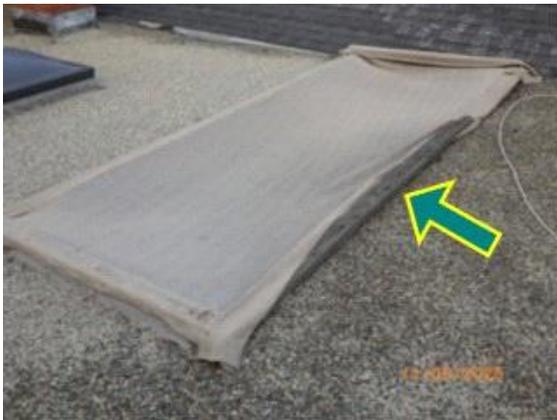
Decayed / detached roof top cloth covering

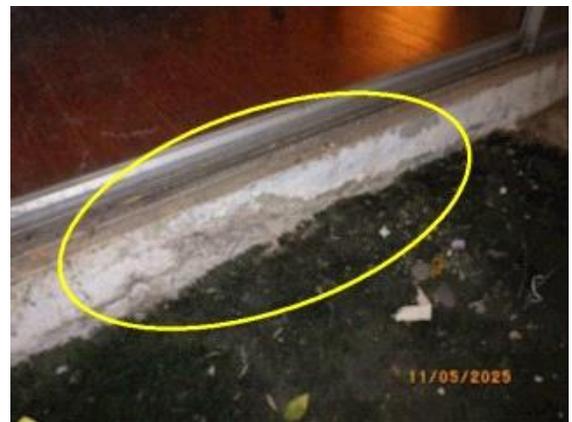
Eroded / decayed stucco siding @ egress thresholds

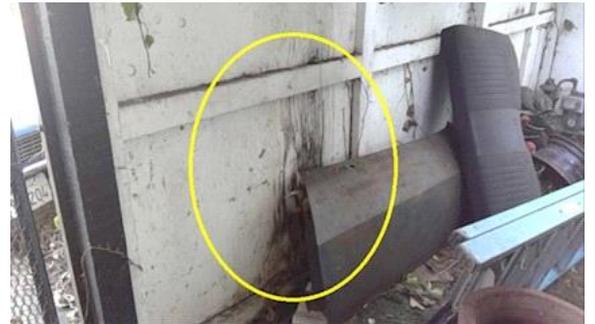
Stained / decayed surfaces

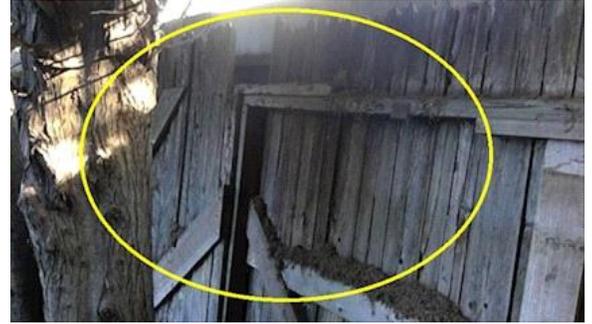
Observed wood rot @ fencing

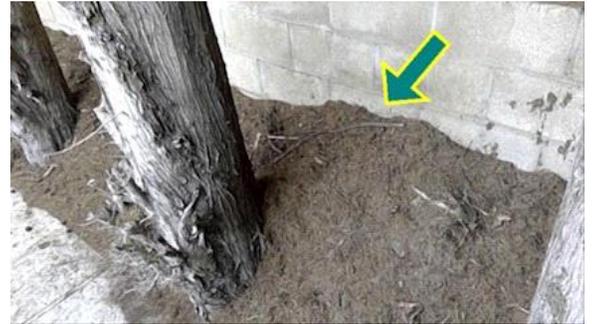
Ex.#2: Retaining wall intact / Unconfirmed - missing weep holes

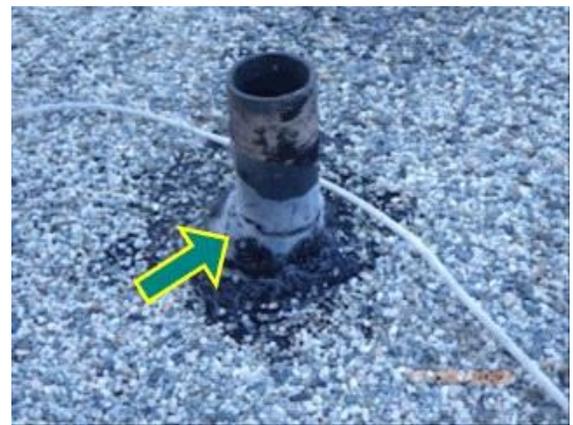
- Damaged / altered drip edge flashing at NW corner.
- Mastic seal on roof jack vents observed deteriorated and/or beginning to crack at various locations.
- Affected assemblies are common areas for possible moisture intrusion.

Cracked / deteriorated mastic sealant

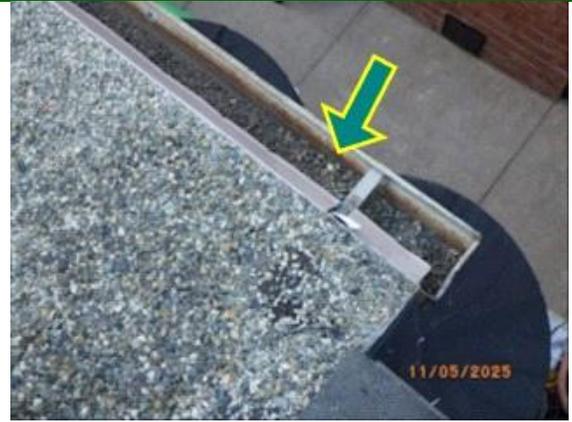
Debris filled gutters.

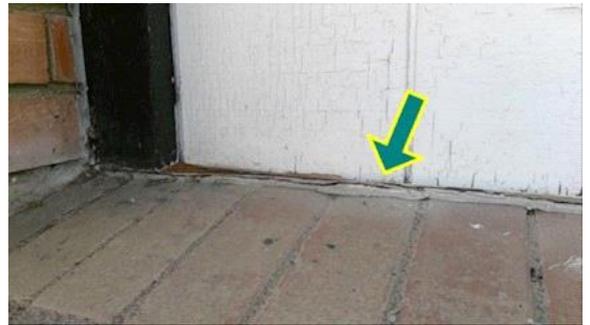
Ex.#2: Separated / deteriorating caulk seam @ flashing assembly

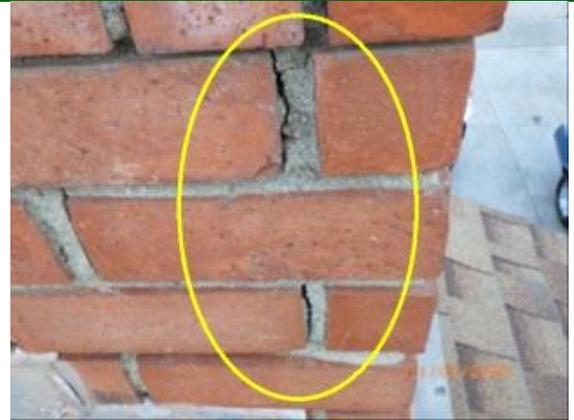
Cracked / eroded mortar @ east side chimney

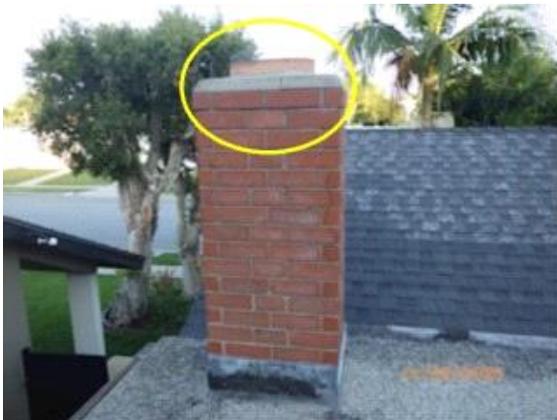
Wire mesh / Missing spark arrestor @ northern chimney

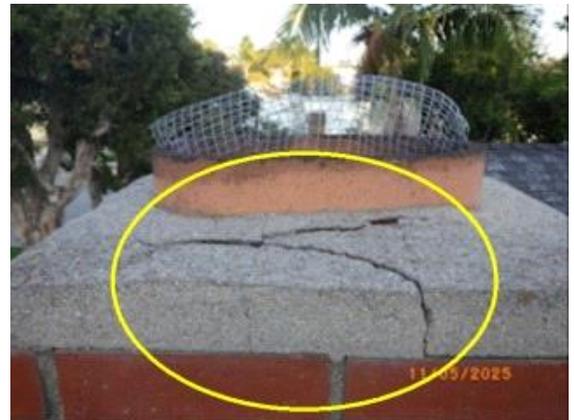
Cracked / separating northern chimney crown

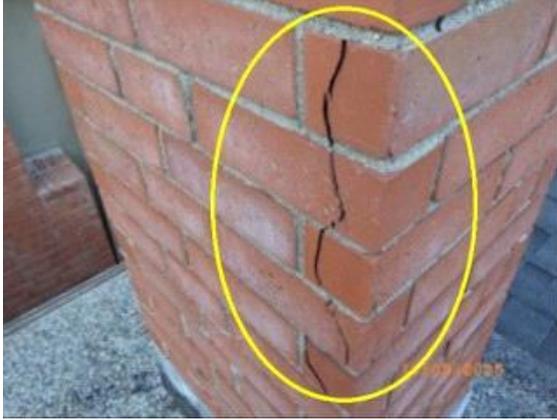
- Cracked / eroded crown and brick and mortar assemblies at more than one course level of northern chimney

Multiple brick course levels cracked @ northern chimney

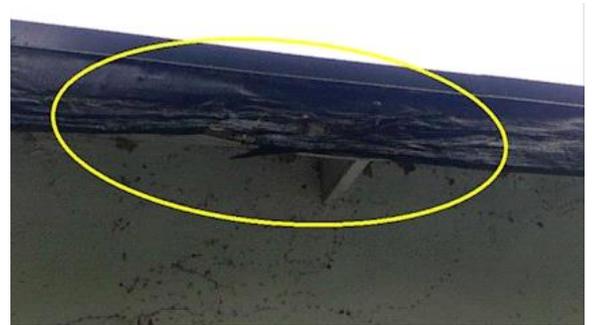
Rotted / decayed fascia

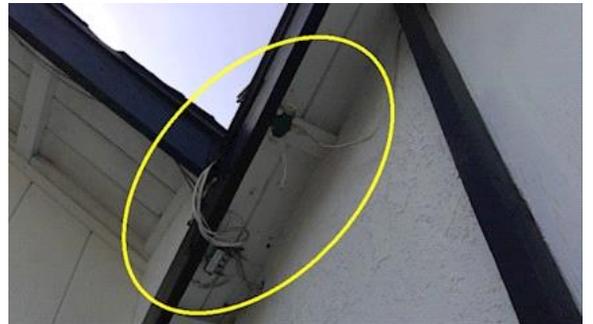
- Multiple extension cords and/or non-permanent cabling were observed attached, draped, or mounted along various exterior wall surfaces at the time of inspection. Extension cords are not rated for continuous exterior use or as a substitute for permanent wiring methods, and exposure to weather, physical damage, or UV deterioration may pose safety concerns. Determining the origin, load, or intended use of these cords is outside the scope of this inspection.

Excess cables & extension cords

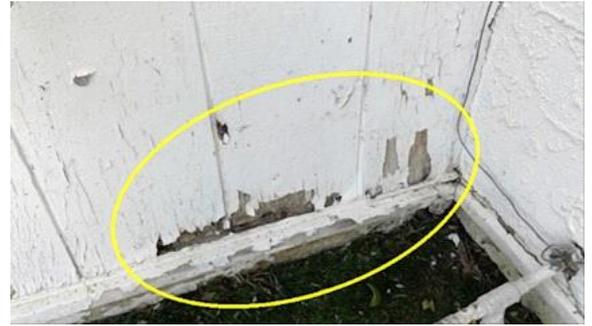
Rotted / decayed wood siding

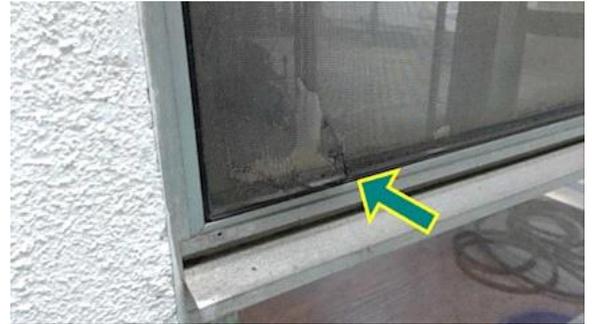
Torn / decayed screens

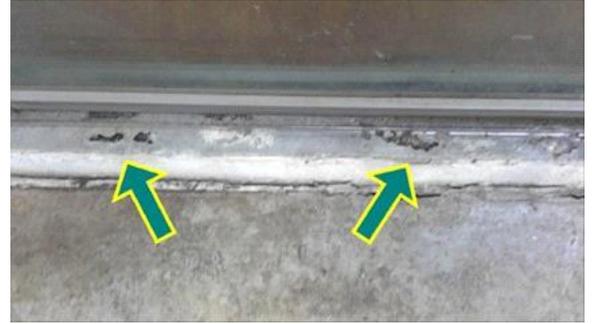
- Spalling, damaged and/or penetrated stucco surfaces below sliding egress thresholds - Potential moisture and/or environmental intrusions area.
- Decayed and/or eroding metal threshold installation at one or more sliding egress thresholds.

Eroded / decayed threshold assembly

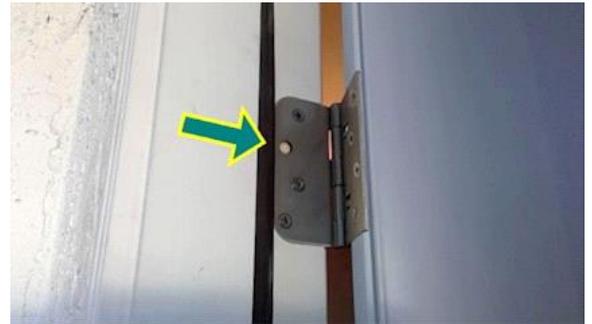
Missing / incomplete hinge screw

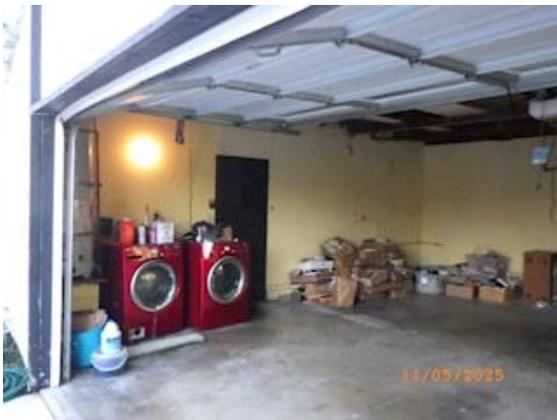
Obstructed / limited interior access & visual inspection

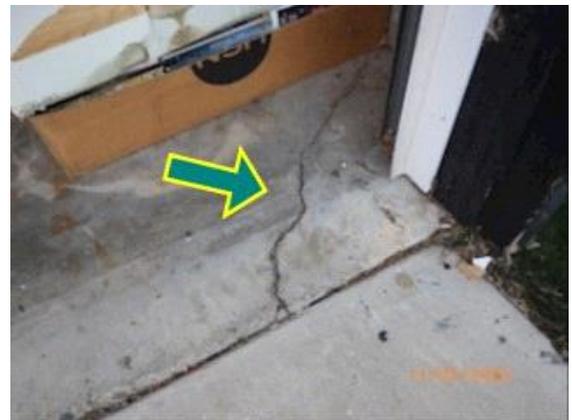
Cracked concrete floor

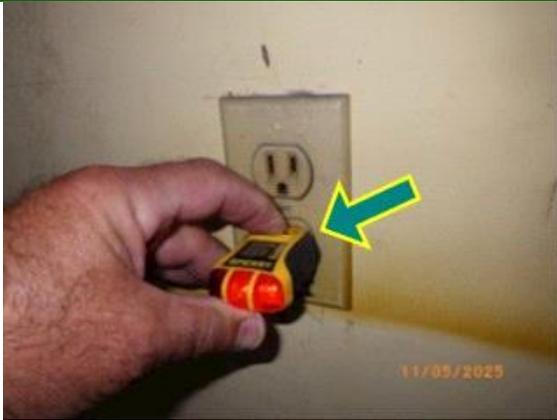
Missing GFCI protection

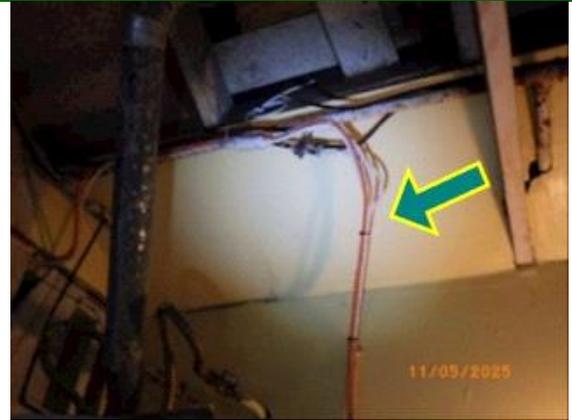
- Random permanently mounted electrical extension cord applications observed within the garage area at the time of inspection. Note: Extension cords by design are intended for temporary use only. For additional safety and peace of mind, recommend removal of all extension cords or related assemblies throughout garage area and upgrading impacted locations by a licensed electrical contractor with current industry approved applications.

"Mounted" extension cord use

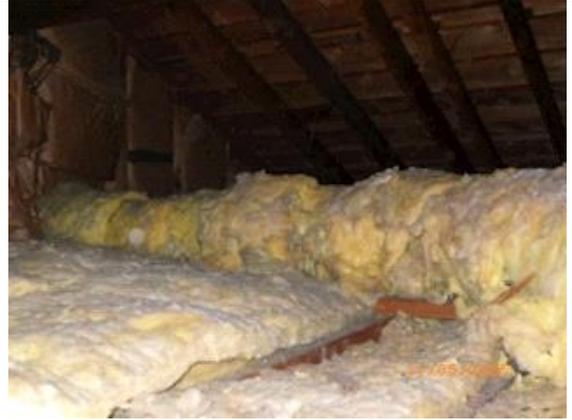
Unsafe interior access - No platforms

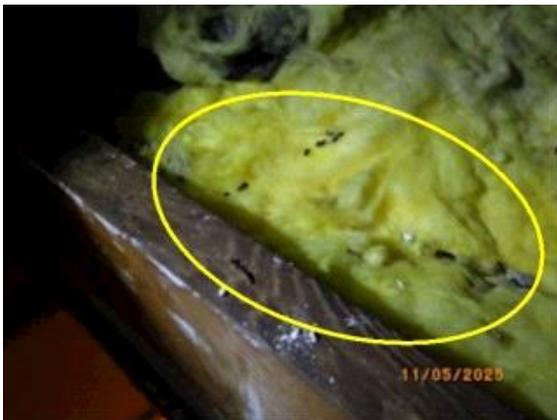
Rodent feces observed

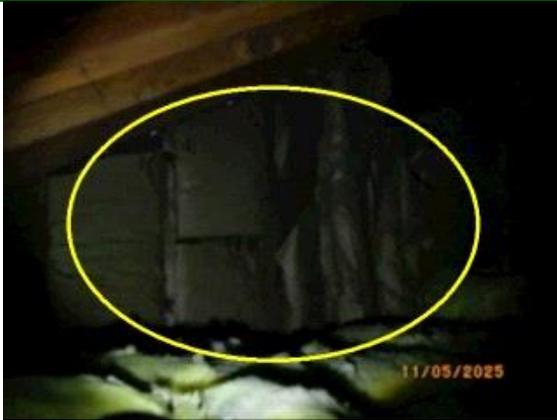
Exposed paper side / Improper installation suspected

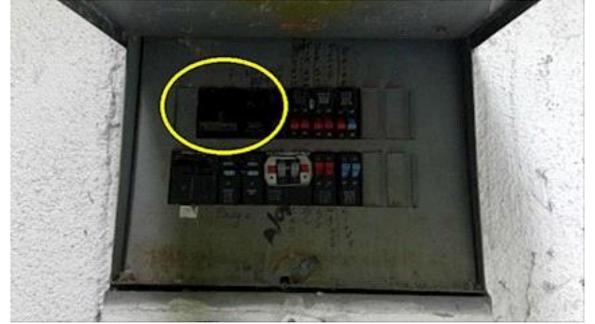
Incomplete, missing or faded circuit breaker labeling

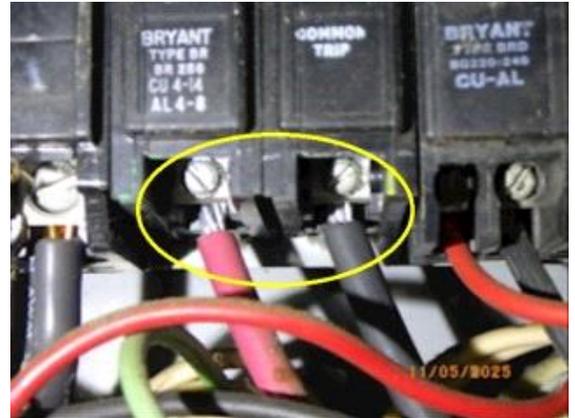
Anti-oxidant gel missing / unconfirmed @ aluminum strand connection

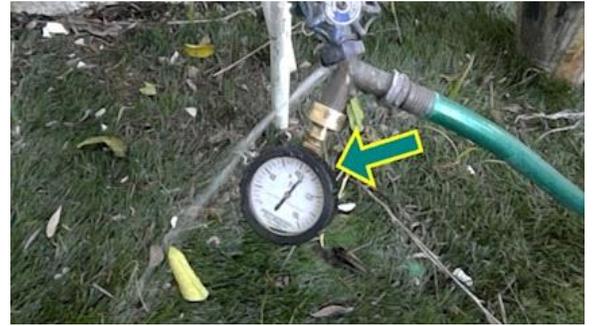
Excessive water pressure observed

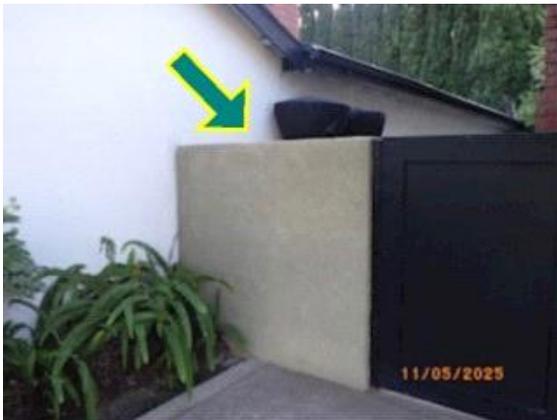
Gas meter located behind neighbors fence

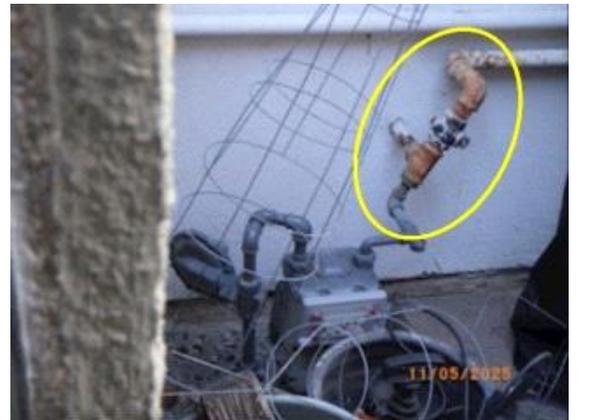
Gas meter intact / Rusted pipe

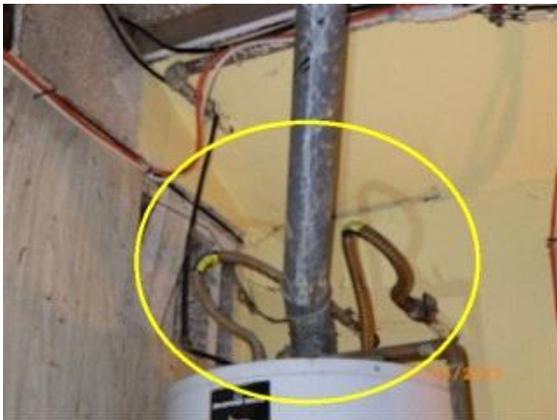
Missing insulated wrap @ supply lines & expansion tank

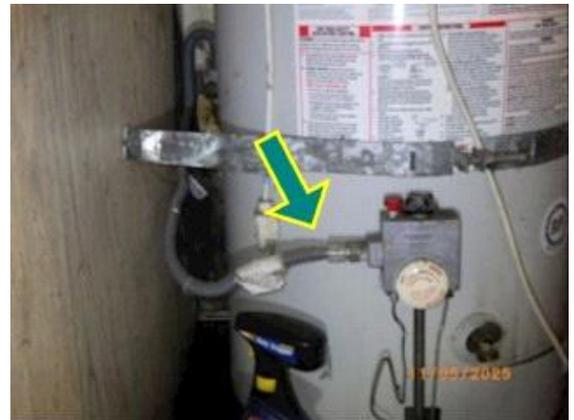
Missing gas drip leg assembly

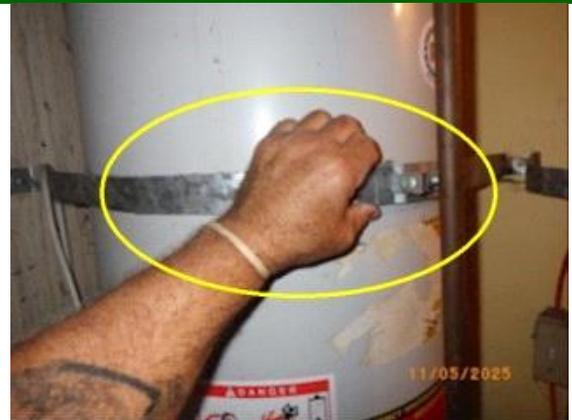
Loose seismic strapping

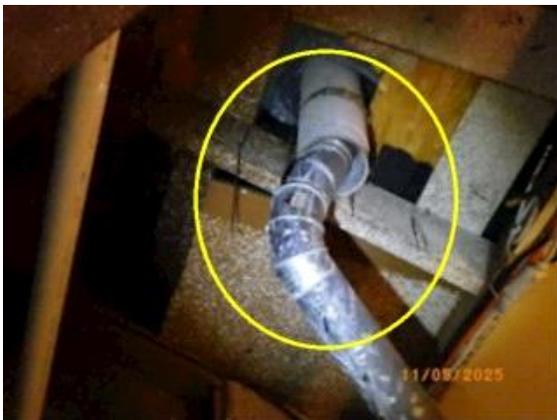
Missing attachment screws @ exhaust flue intersections - Transite / asbestos vent pipe

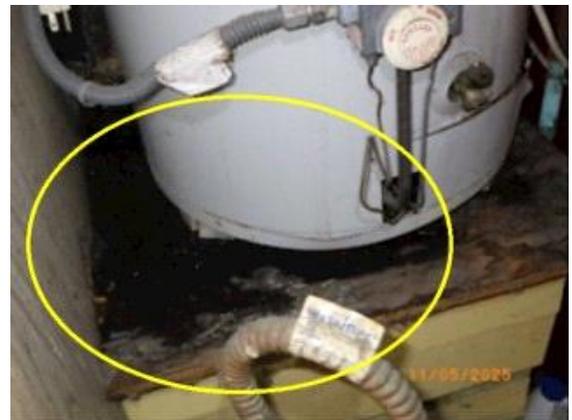
Pooling water @ platform

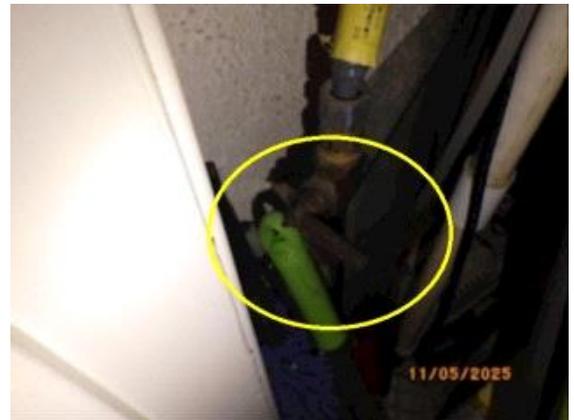
Inactive gas supply

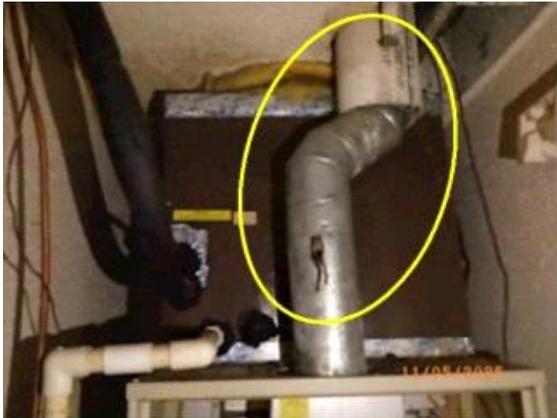
- Single wall vent pipe at internal vertical exhaust assembly observed at time of inspection. Note: Current standards indicate double wall B-vent exhaust vent pipe be present for internal assemblies and that single wall vent pipes are no longer allowed. Recommend licensed HVAC contractor further evaluate all client concerns and/or upgrade to within current industry standards for additional peace of mind.

- Note: Sections of draft control venting are composite (Transite) material and may or may not contain asbestos type particles due to age of dwelling. Although asbestos material can dangerous; if left undisturbed, it can be an acceptable application. Recommend all concerns and/or diagnosis be further evaluated by a licensed air quality inspector.

Single wall vent pipe & transite / asbestos type material present

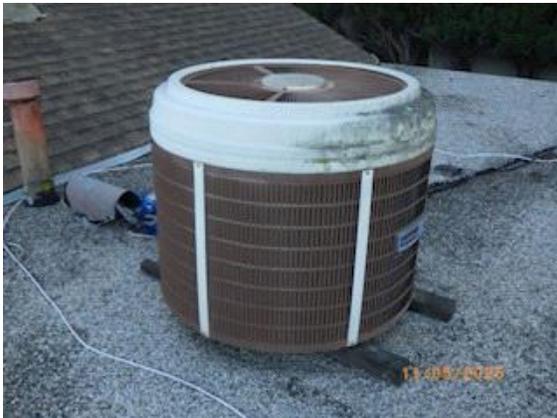
- The homeowner stated that the air conditioning system has not been operational for an extended period of time. The system was not operated or tested at the time of inspection. Visual inspection was limited to the readily accessible roof top components only; internal condition, refrigerant levels, capacity, and overall performance could not be confirmed. Recommend further evaluation and repair or replacement as needed by a licensed HVAC contractor prior to close of transaction and/or prior to reliance on the system for regular use. Additional costs should be anticipated.

Unconfirmed / inoperable roof top mount condenser unit

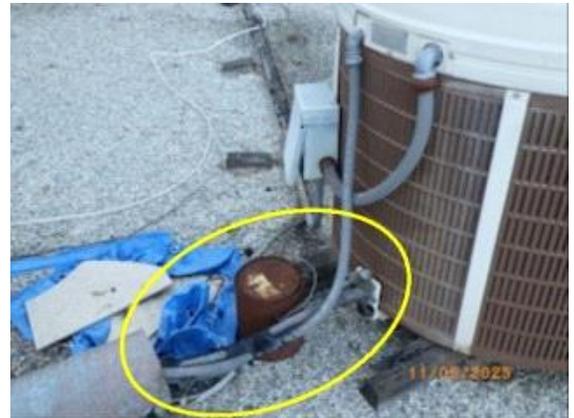
Deteriorated, missing or damaged insulated wrap @ suction line

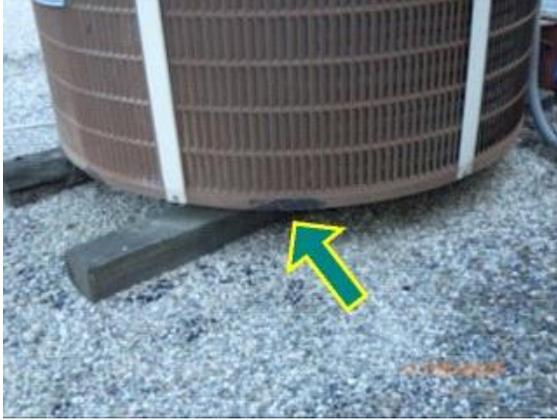
- Additional Note: Conventional hold-down (anchor) straps at base of unit to level pad missing at time of inspection. Industry standards indicate supports and foundations shall be mounted in a manner to prevent excessive vibration, settlement or movement, be level and conform to manufacturers installation guidelines. Recommend all stated (but not limited to) conditions be further evaluated and repaired within an agreed upon duration of time by licensed contractors of the appropriate trade:

Missing anchor straps @ base of Condenser

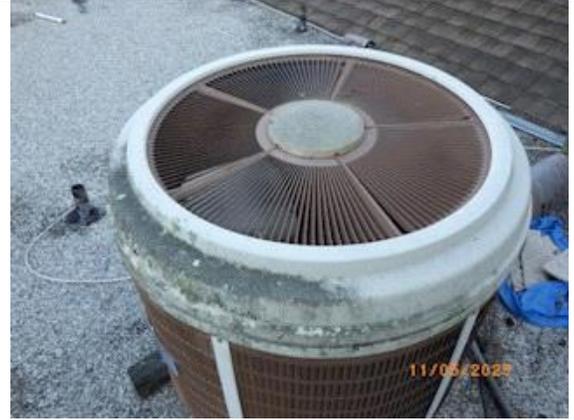
Rusted / stained surfaces

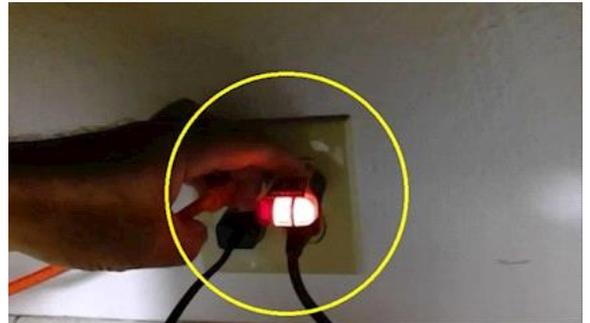
Missing GFCI outlet / circuit protection

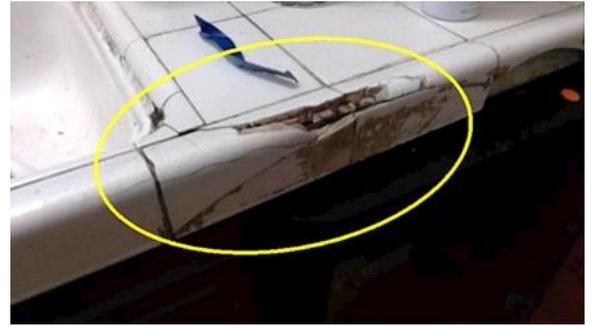
Damaged counter top tile

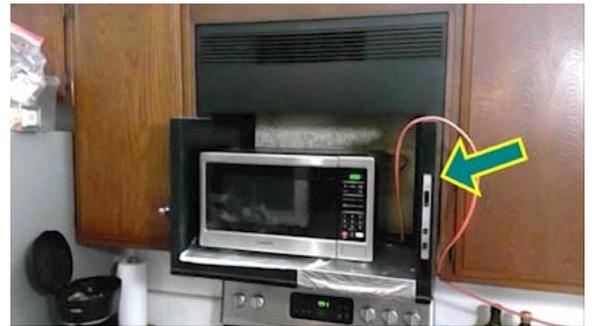
Dismantled / unconfirmed exhaust fan appliance elements

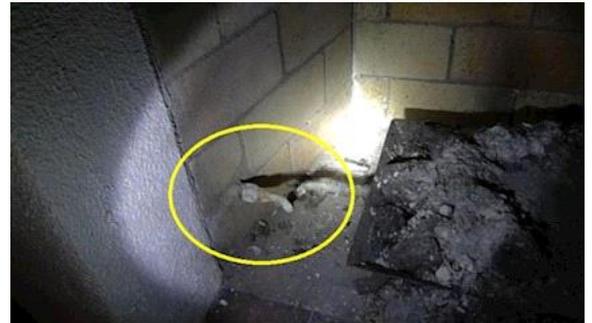
Rusted / corroded gas supply

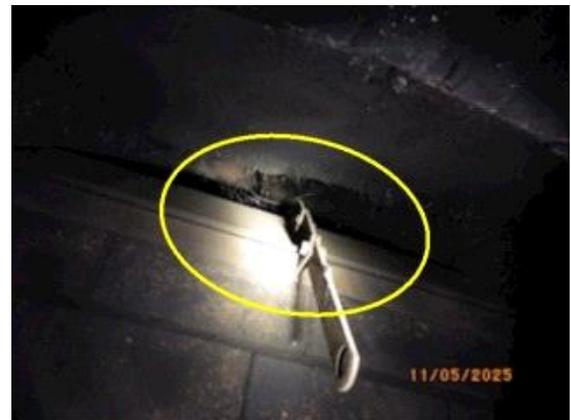
Missing Damper stop assembly

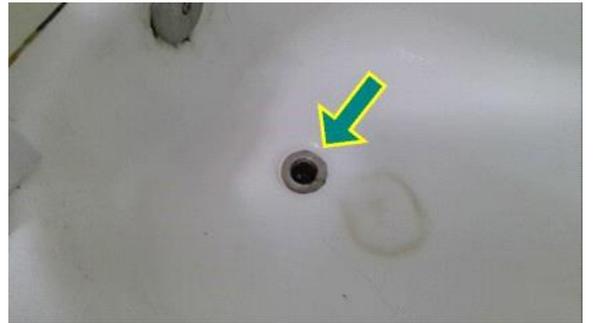
Dismantled bathtub stopper

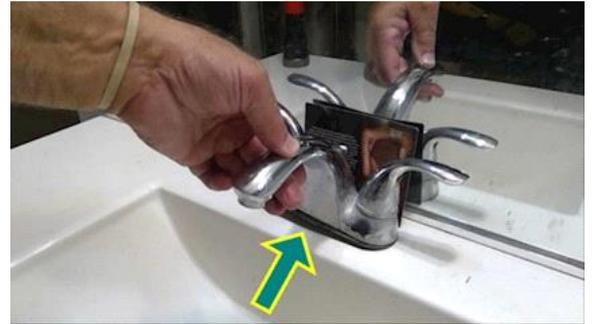
Loose faucet mounting

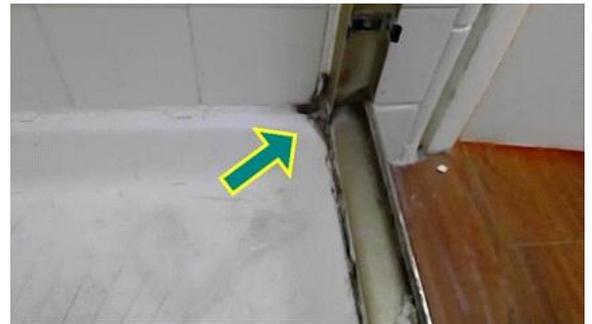
Microbial substances @ shower pan seams

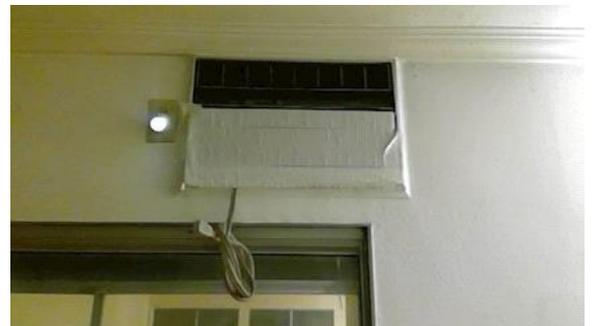
Unplugged / altered wall mount AC unit

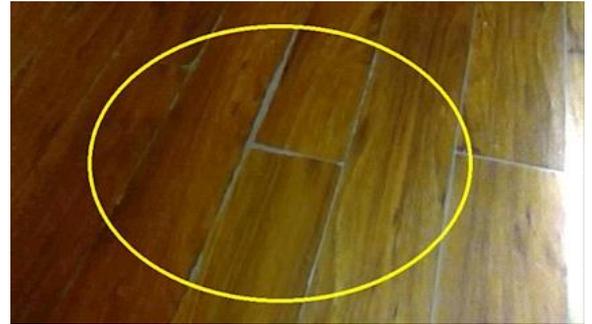
Delaminated / gouged finish flooring

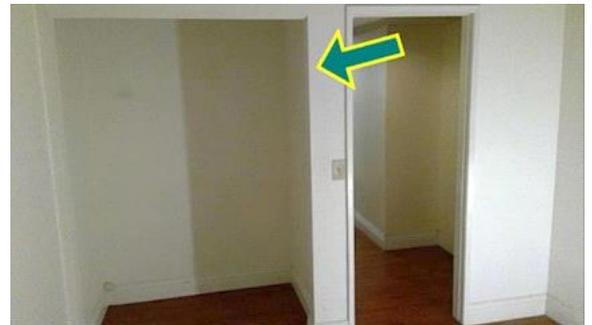
Bedroom 1 / Interior view #2 - Missing closet doors

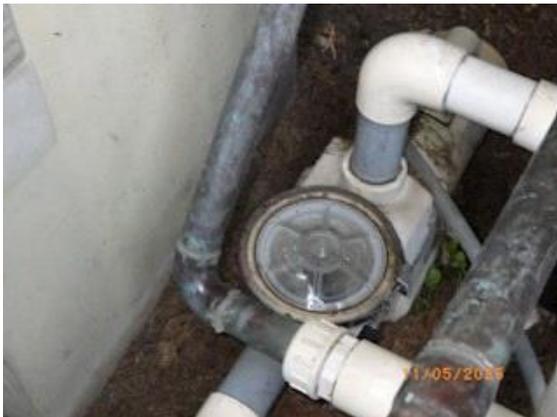
Exposed / unsealed PVC pipes / Unconfirmed - missing variable speed pump

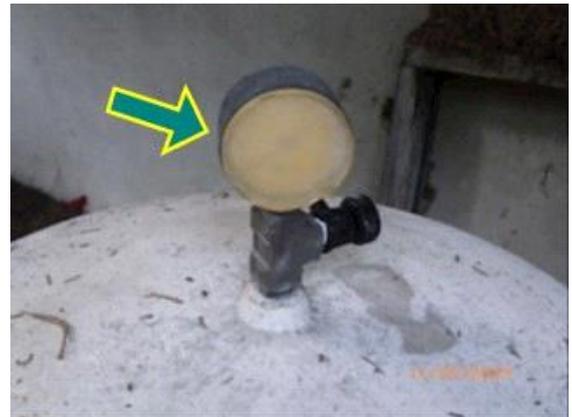
Unreadable PSI gauge @ DE filter

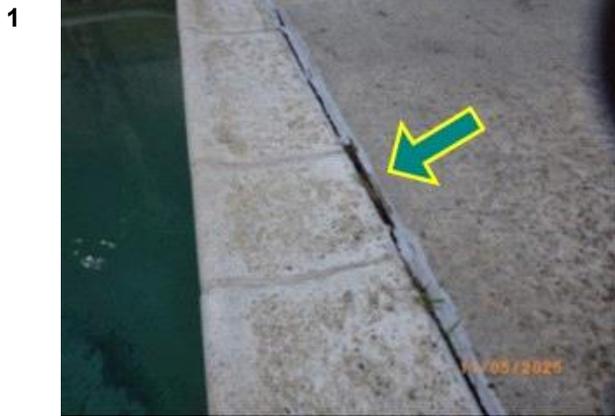
Cracked / eroded mastic sealant @ pool coping

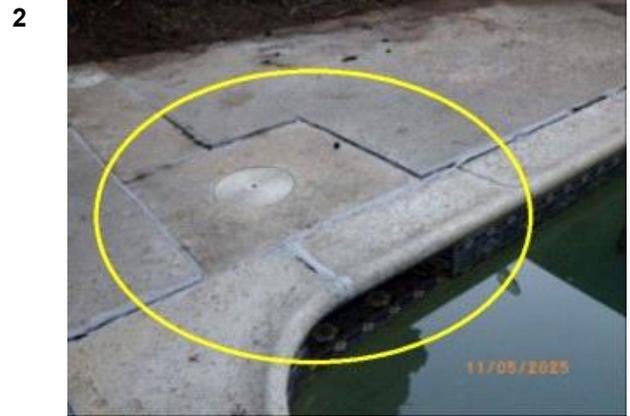
Unlevel pool deck surfaces - Tripping hazard

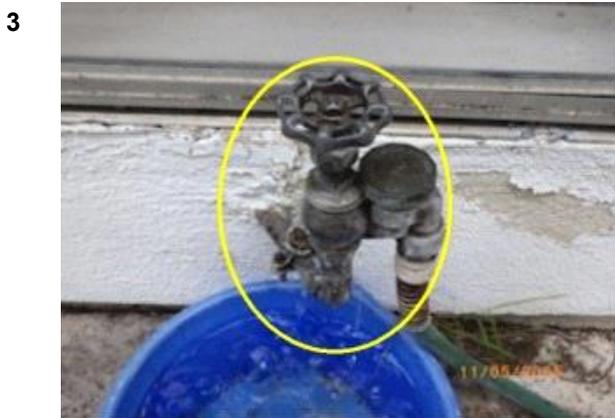
Leak detection @ pool fill valve assembly

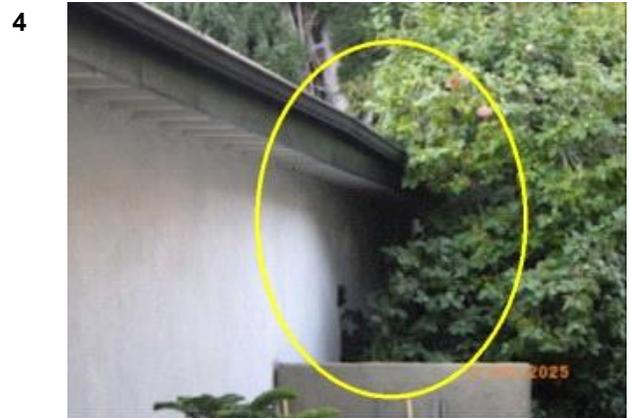
Zero lot line @ north side / Over-grown vegetation in contact with structure

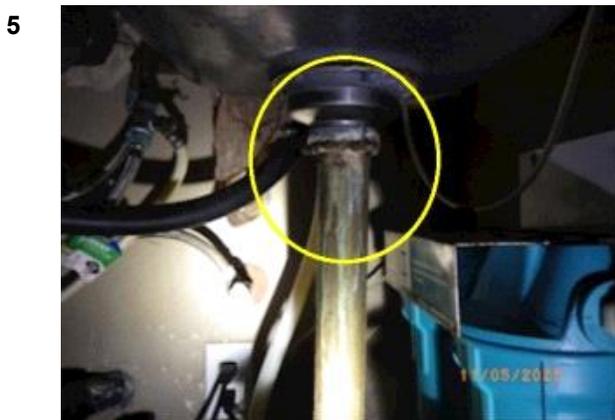
Leak detection below kitchen sink

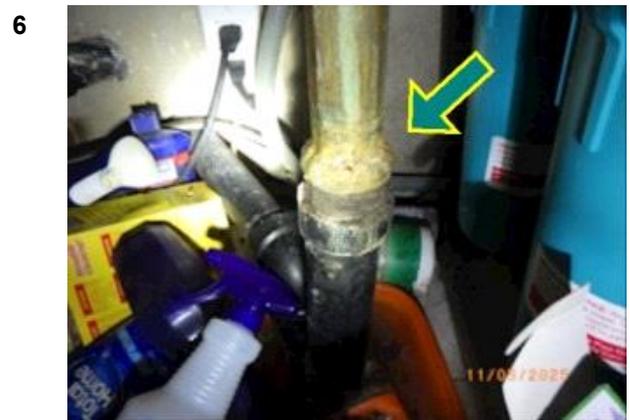
Corroded plumbing assemblies below kitchen sink
