# National Property Inspections

Randy Shaver - Trustee, 12942 Yorba Street, Santa Ana, CA, 92705

Inspection Date:  
08/23/2026

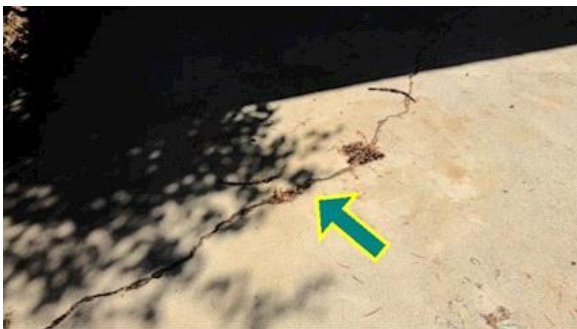
Cracking conditions observed

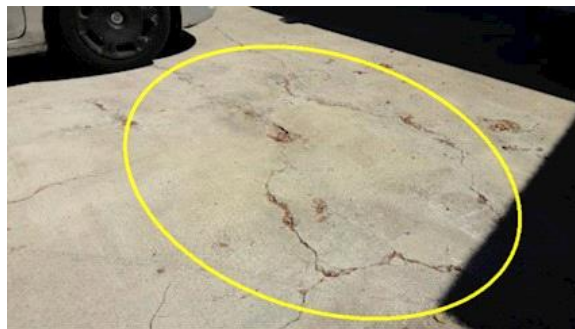
Indented / eroded concrete

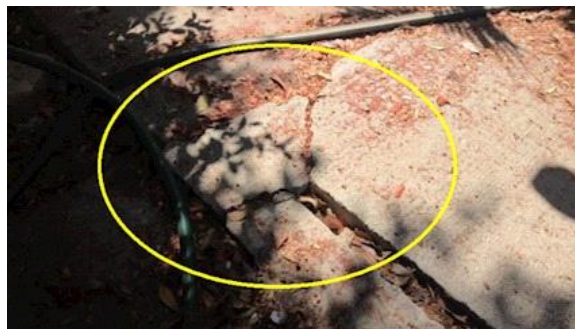
Cracked concrete

• Observation(s): Deterioration and cracking were present at more than one flatwork surface area. The specific cause of these conditions could not be determined at the time of inspection. Such conditions are commonly associated with age-related wear, material movement, or environmental exposure. At the time of inspection, the affected areas appeared generally level; however, changes in condition over time could result in uneven surfaces or a potential trip or safety hazard. Recommend monitoring the areas for further changes and, if concerns exist, further evaluation by a licensed contractor of the appropriate trade.

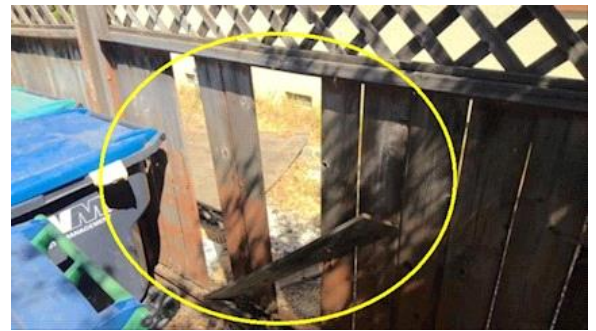
- Misaligned, unsecured / detached and/or leaning wood planking or related installations observed at various perimeter locations.
- Damaged, rotted and/or decayed wood planking and/or related installations observed at multiple areas.
- Note: Affected installations may or may not be a shared responsibility with neighboring property owner.

Damaged / missing wood planking

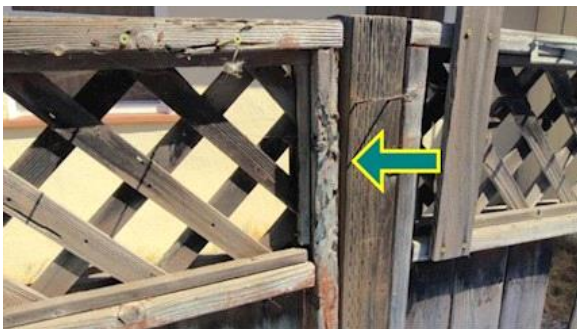
Decayed, rotted wood surfaces / components

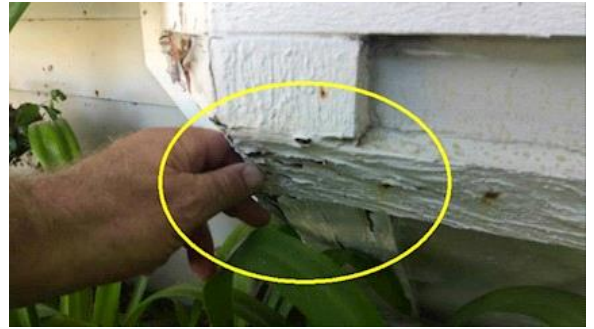
Wood rot, decay and/or suspected termite related conditions

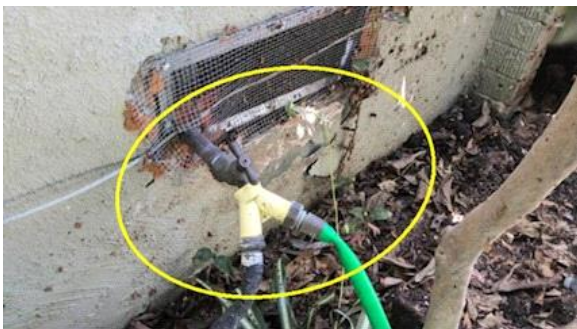
Damaged stucco / Missing vacuum breaker @ hose bib(s)

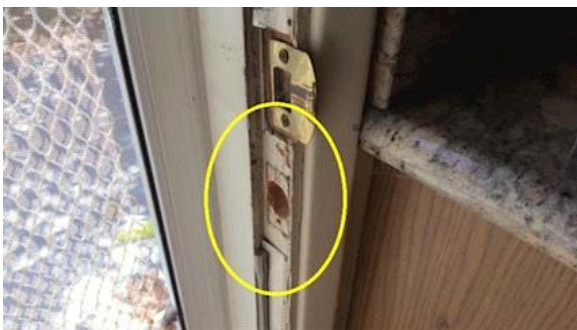
Missing latch plate

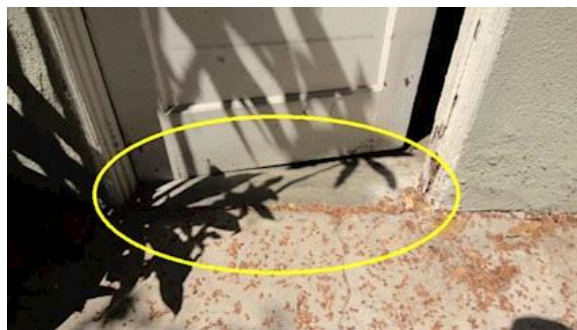
Minimal threshold height

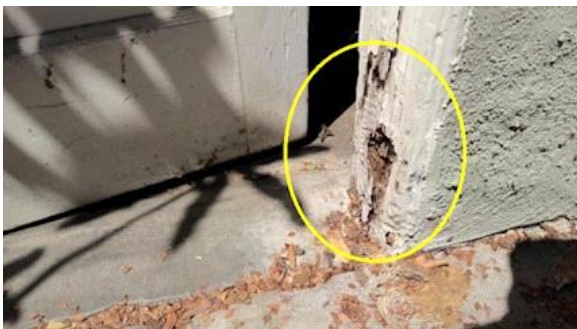
- Decayed, rotted wood conditions at external garage door surfaces.
- Recommend performing / consulting termite inspection report for additional information and all details pertaining to repair, replacement and/or treatment be completed by licensed contractors of the appropriate trade.
- Inoperable / unconfirmed door bell function as intended.
- Cracked / separating front door edge.

Wood rot, decay and/or suspected termite related conditions

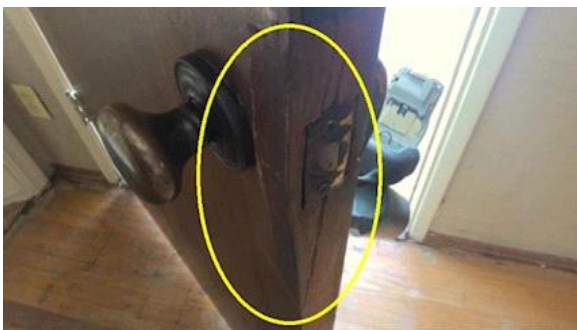
Cracked front door edge

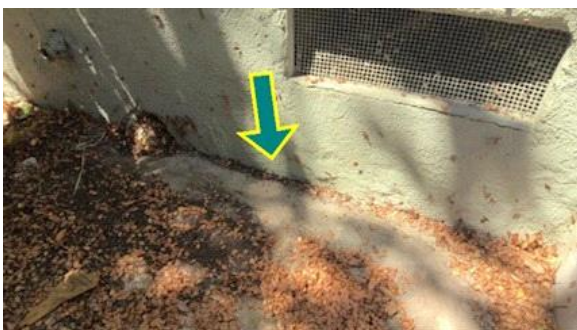
No weep screed / Potential moisture intrusion

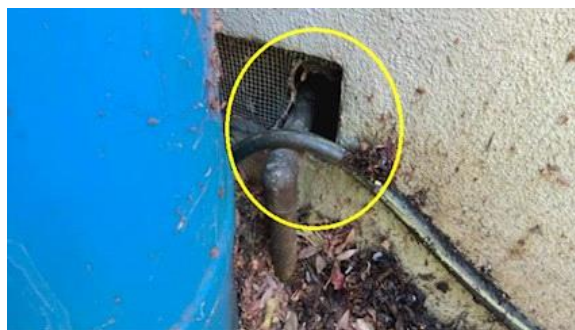
- Random exterior Crawlspace vent covers detached, with enlarged openings, and/or damaged rendering concern for possible small animal or rodent intrusion to occur.

Deteriorated, damaged or misaligned vent screens

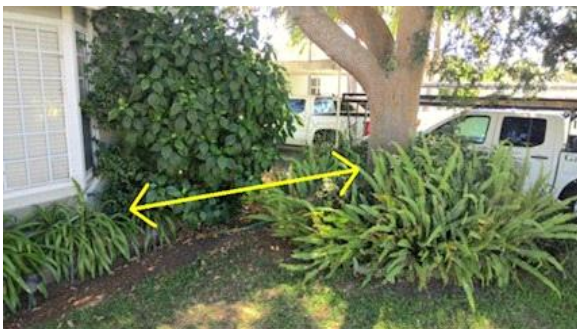
Tree root proximity to foundation

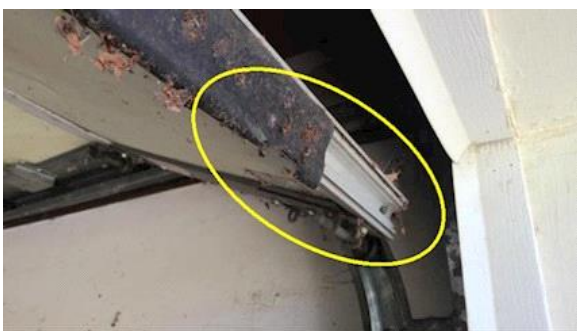
Detached, altered / partially missing weather strip

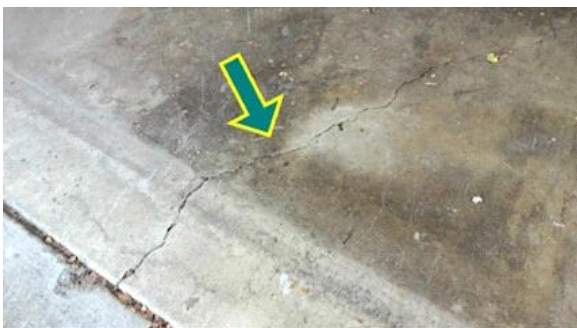
Cracked concrete surface(s)

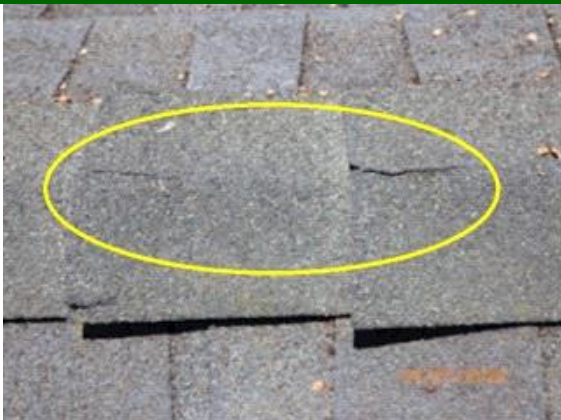
Cracked ridge caps

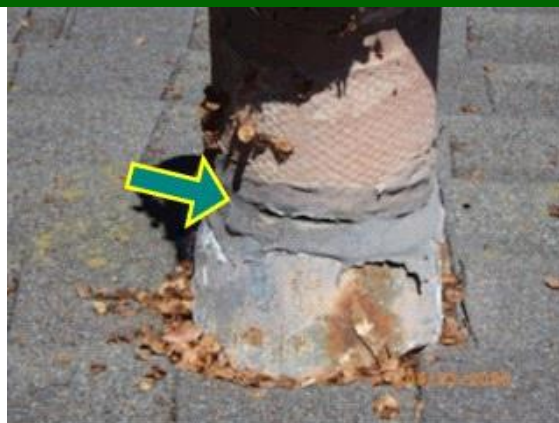
Ex.#1: Cracked / deteriorated mastic sealant

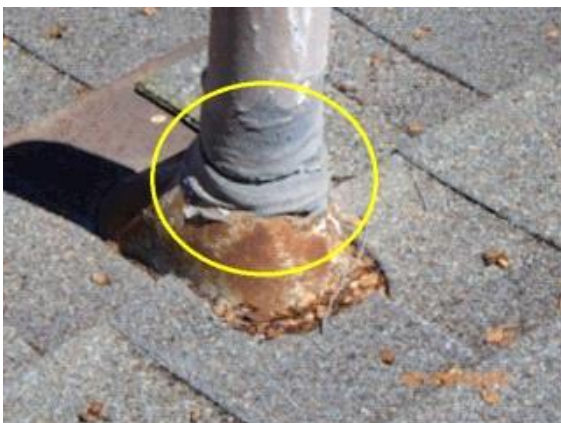
Ex.#2: Cracked / deteriorated mastic sealant

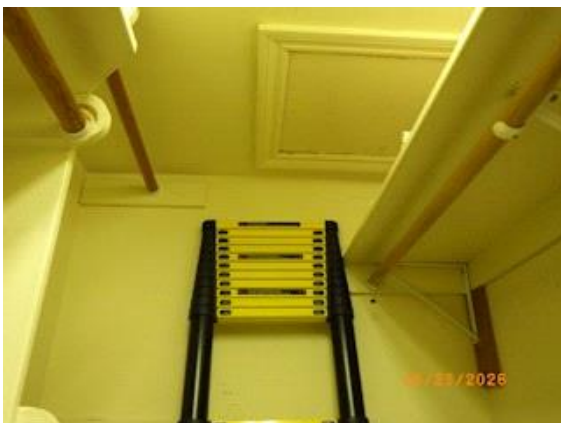
- Attic scuttle (opening) obstructed by closet shelving installation rendering unsafe access for this inspector without removal or significant dismantling of interior shelving assemblies. In addition, excessive amount of loose fill insulation was encompassing the immediate area and opening. Note: This inspection process is of readily available areas and dis-assembly is not within the scope of this inspection. In addition, industry standards of practice indicate the inspector is not required to enter any crawlspace that is not readily accessible or where entry could cause damage or pose a hazard to the inspector. Recommend all client concerns be further evaluated by licensed contractors of the appropriate trade when accessibility can be attained.

Limited / unsafe attic access

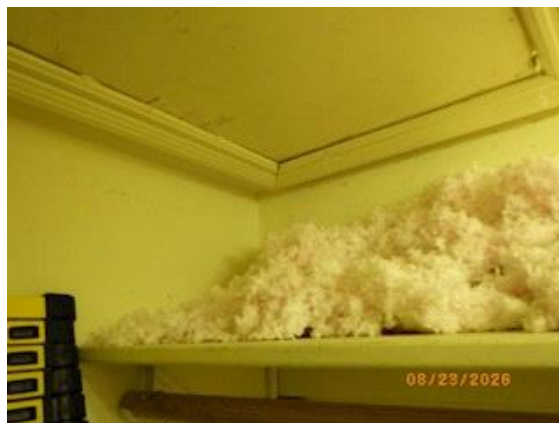
Obstructions @ attic entrance

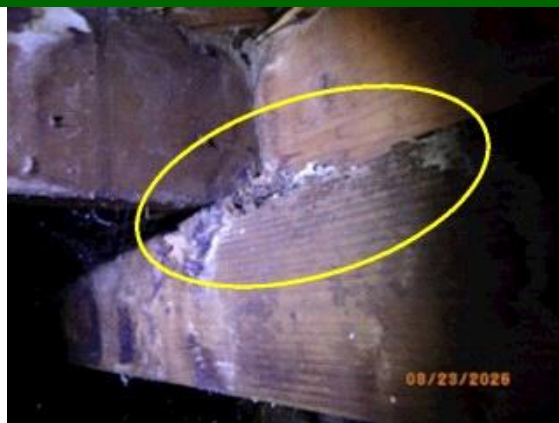
- Termite dusting / feces substances and suspected tubes were observed at more than one interior framing and perimeter foundation wall surfaces.
- Recommend performing and consulting a termite inspection report for additional information and remediation processes.

Ex.#1: Wood rot / suspected termite conditions @ framing & support

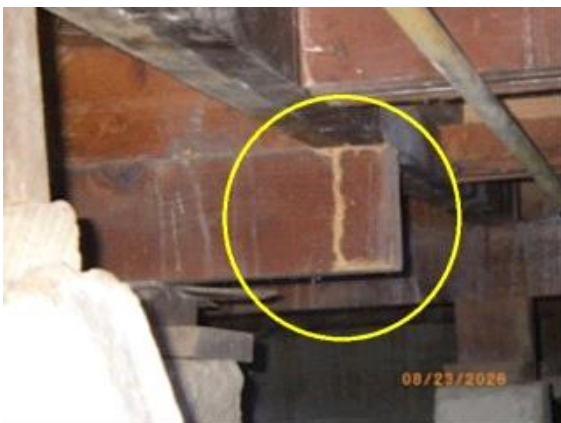
Ex.#2: Wood rot / suspected termite conditions @ framing & support

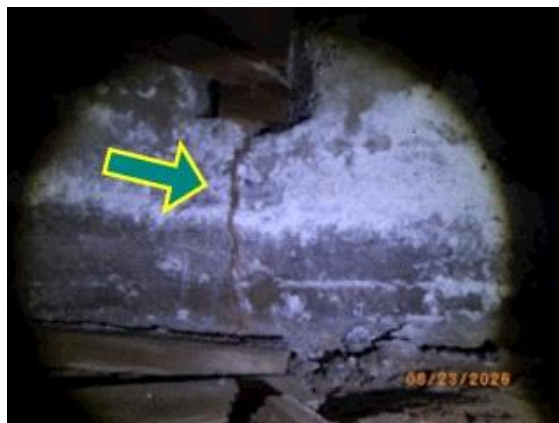
Suspected termite tube & efflorescence / chalky substance present

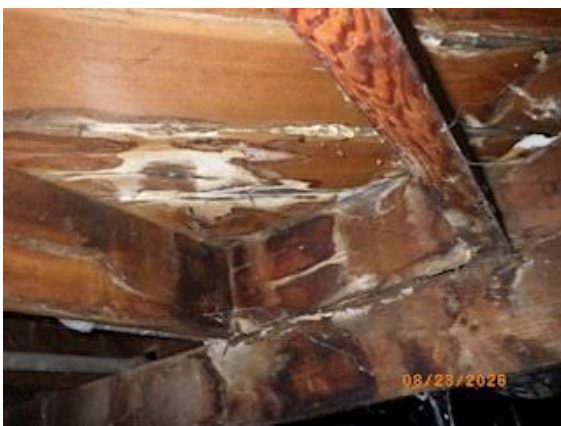
Stained / deteriorated wood conditions

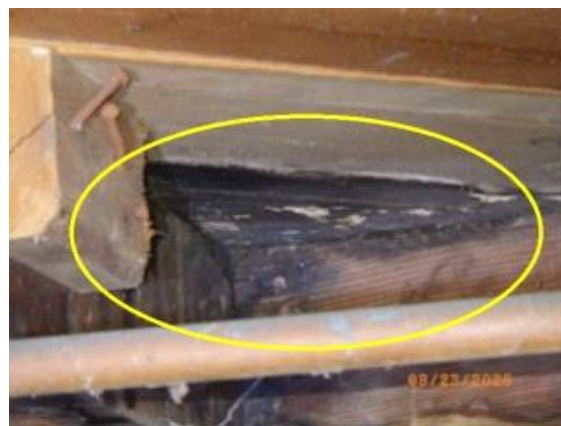
- Microbial-type discoloration and/or unidentified surface growth was observed at random areas of the sub flooring and associated wood framing. The nature, extent, source, and significance of these conditions cannot be determined by visual observation alone and are beyond the scope of this inspection. Further evaluation and/or testing should be performed if additional determination is desired.

Black-like discoloration observed @ sub flooring

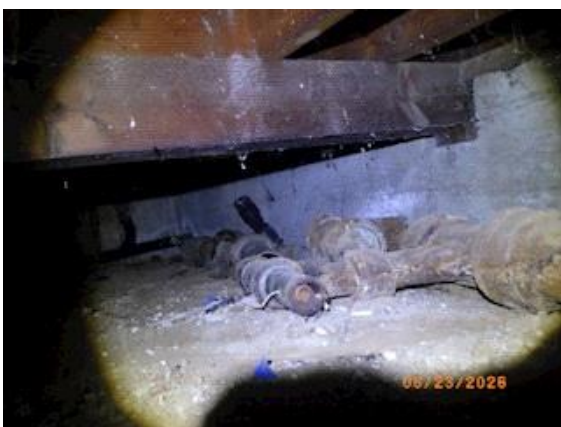
• Additional Note: Original galvanized and iron pipe plumbing has been upgraded but old installations and residual debris are still present within crawlspace areas. Typical upgrades involve removal of old galvanized piping installations and related debris. Recommend all concerns be further evaluated and/or removed by a licensed contractor of the appropriate trades.

Dismantled old plumbing system debris

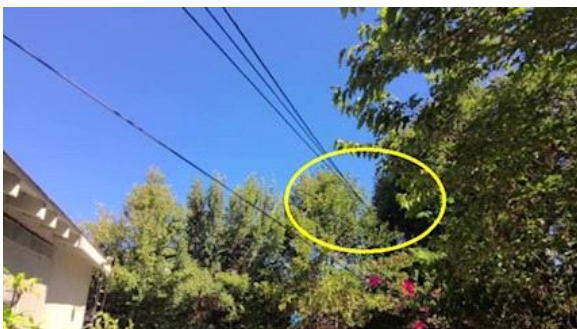
Overhead service entwined with tree limbs

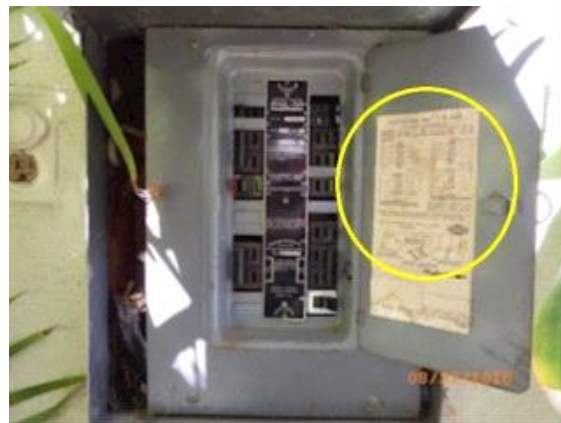
- Main OCPD dead front panel observed with faded or incomplete labeling to identify what breakers supply what circuits. Note: Current industry standard indicates "purpose" of all breakers / fuses be legibly marked. For additional safety recommend identification and labeling of all specific breaker functions by a licensed electrical contractor.

Incomplete, missing or faded circuit breaker labeling

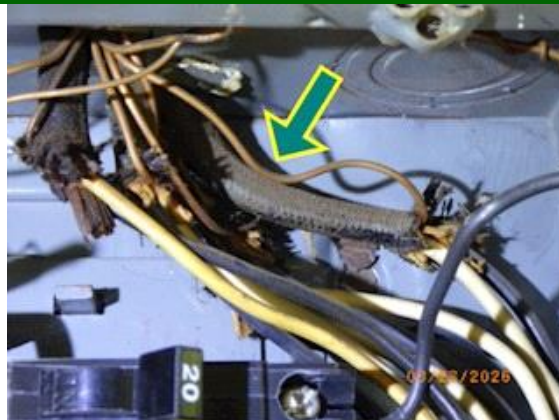
Antiquated conductors / Cloth-wiring observed

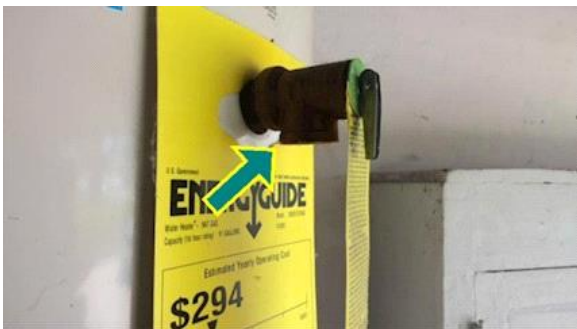
Missing TPRV drain pipe assembly

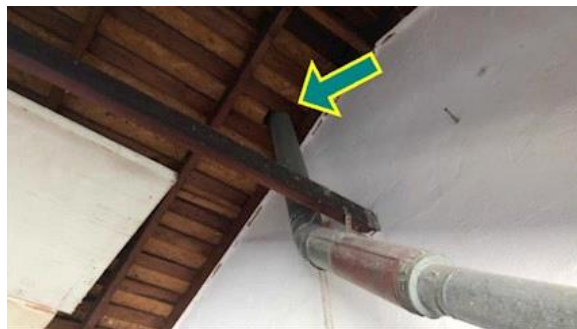
Minimum clearance around exhaust pipe not present

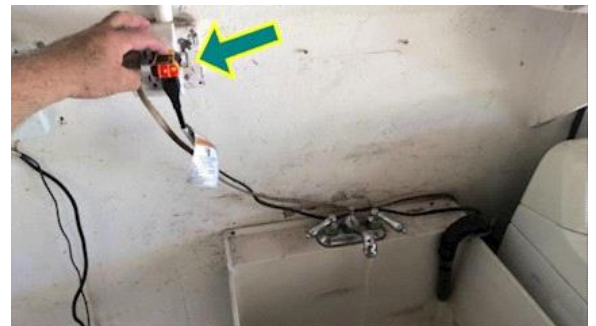
Missing GFCI protection @ electrical outlet

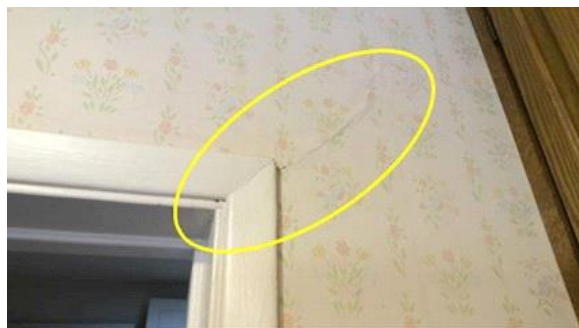
Diagonal cracking above door

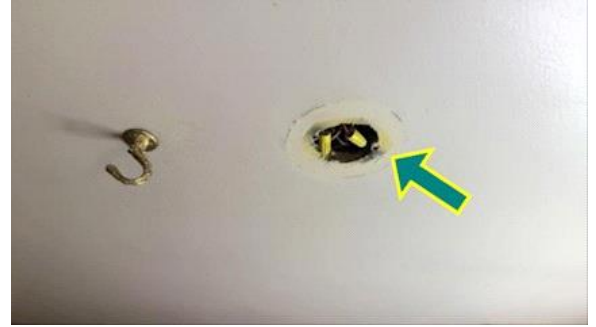
Missing j-box cover / Exposed electrical

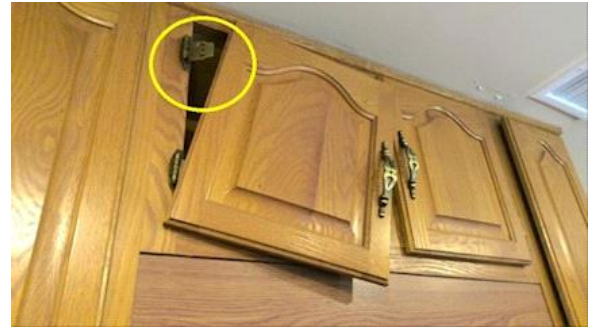
Detached wall cabinet door

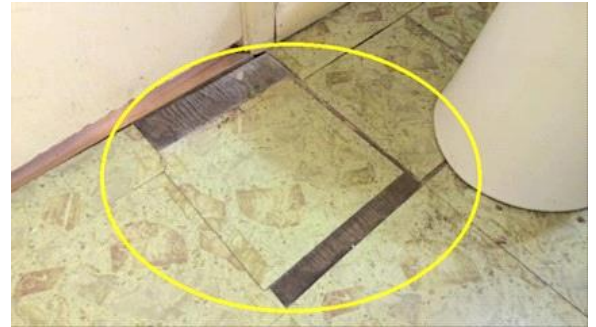
Displaced / loose floor tile

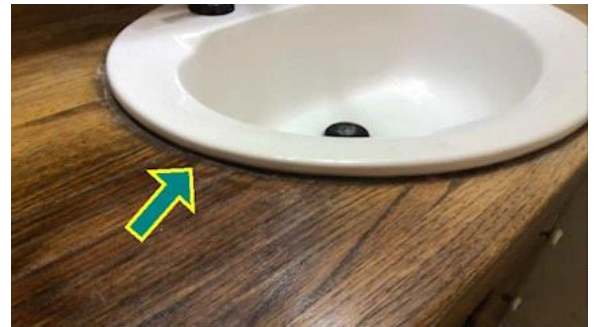
Basin loose & lifting

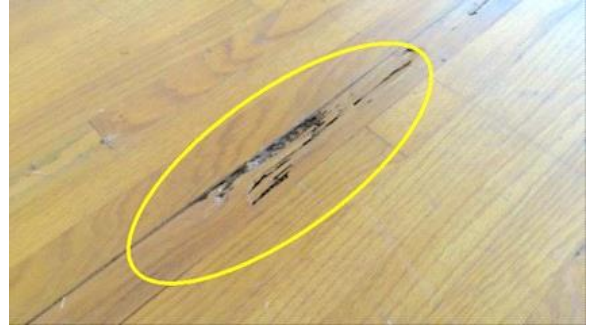
Rotted / decayed wood flooring

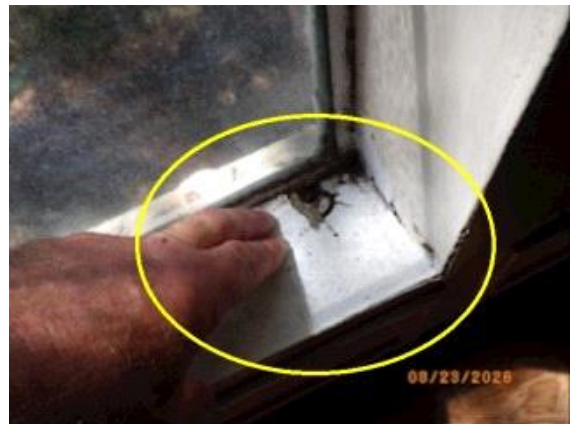
Rotted / decayed window sill surfaces

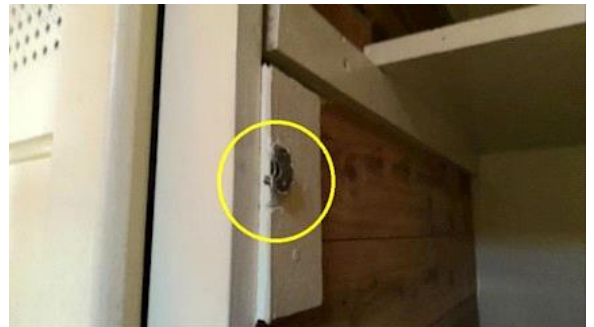
Altered / missing cabinet door latch hardware

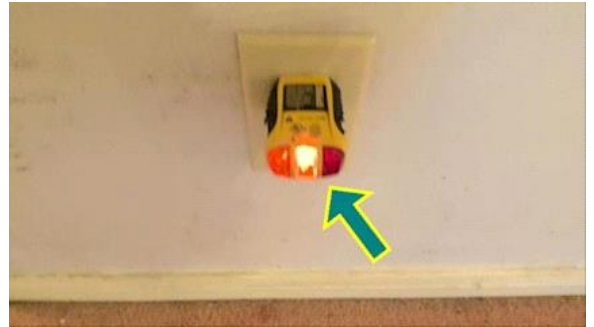
Open ground detected

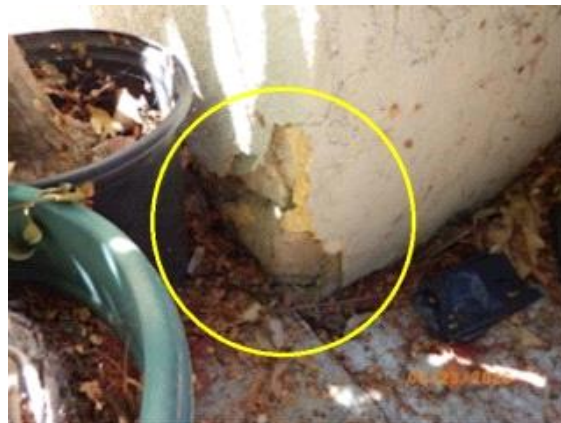
3

Damaged / penetrated stucco surfaces

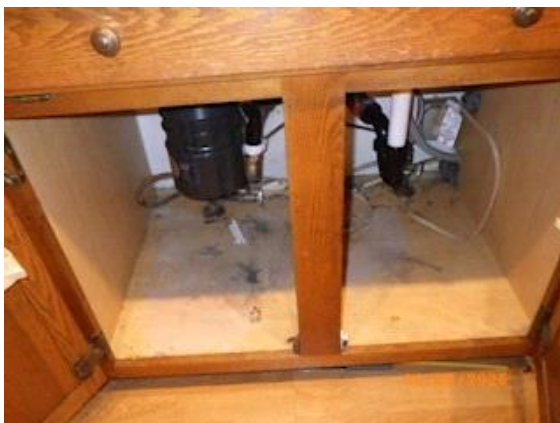
4

Ex.#1: Stained / deteriorated surfaces below kitchen sink

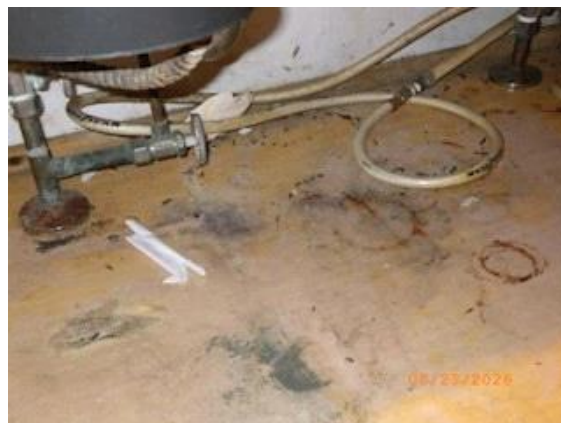
Ex.#2: Stained / deteriorated surfaces below kitchen sink

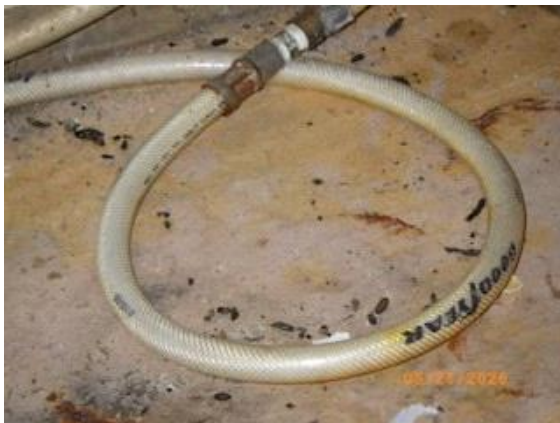
6

Rodent feces observed below kitchen sink

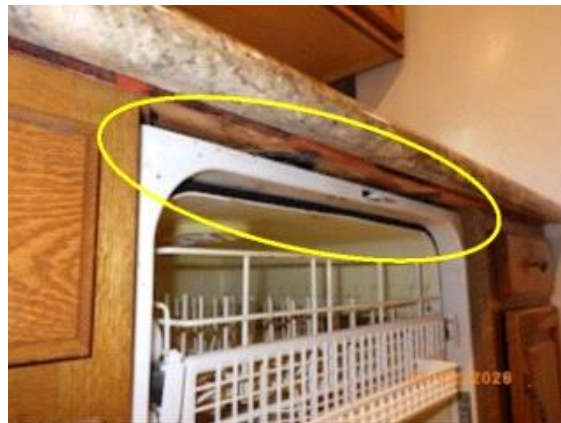
7

Unsecured dishwasher mounting

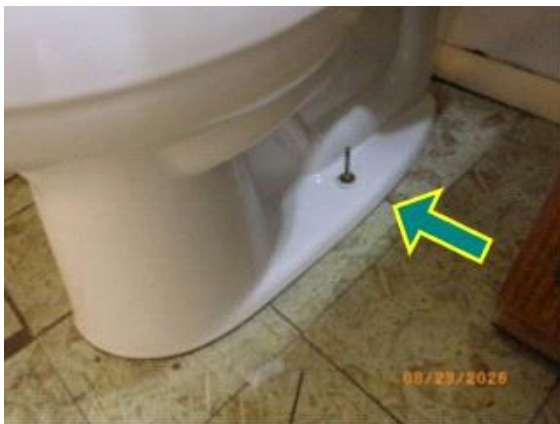
10

Loose / unsecured toilet mounting

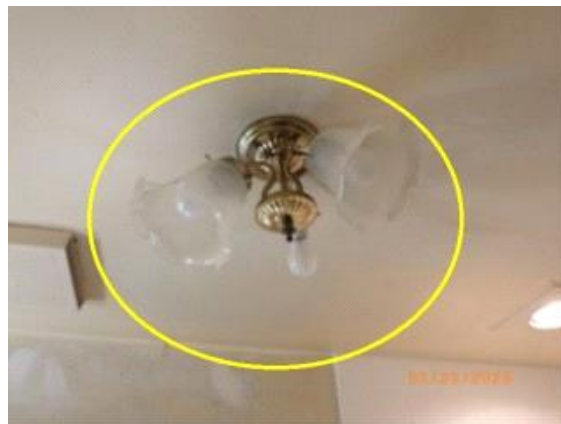
Unconfirmed bathroom ceiling light fixture / Missing protective globe

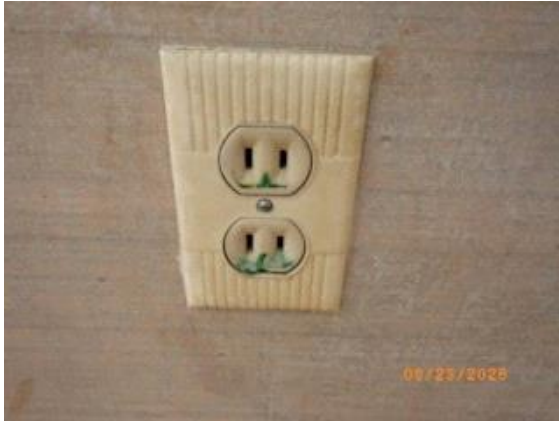
12

Antiquated two-prong outlets observed

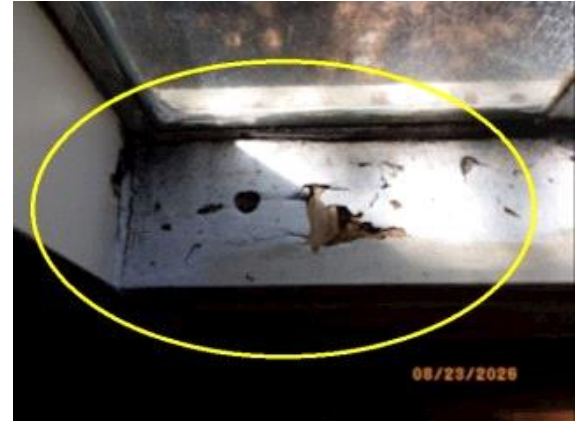
Additional example: Rotted / decayed window sill surfaces @ family room
