# National Property Inspections

Randy Shaver - Trustee, 12942 Yorba Street, Santa Ana, CA, 92705

Inspection Date:  
08/23/2026

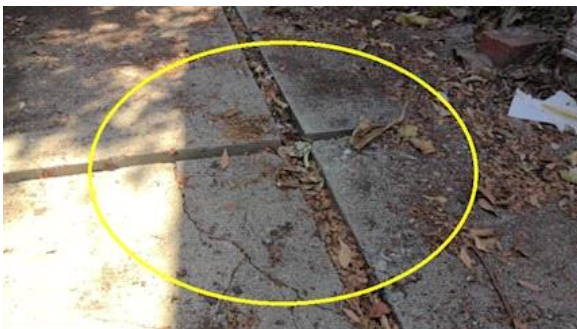
Unlevel surfaces / Recessed expansion joints

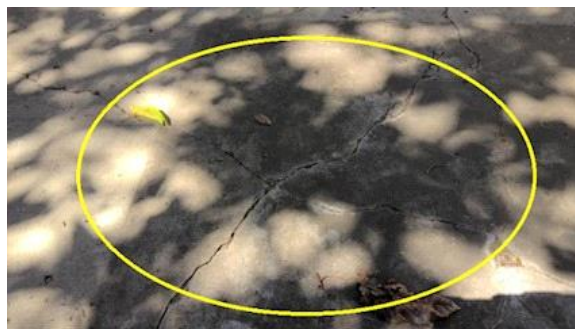
• Observation(s): Deterioration and cracking were present at more than one flatwork surface area. The specific cause of these conditions could not be determined at the time of inspection. Such conditions are commonly associated with age-related wear, material movement, or environmental exposure. At the time of inspection, the affected areas appeared generally level; however, changes in condition over time could result in uneven surfaces or a potential trip or safety hazard. Recommend monitoring the areas for further changes and, if concerns exist, further evaluation by a licensed contractor of the appropriate trade.

Cracked concrete surfaces

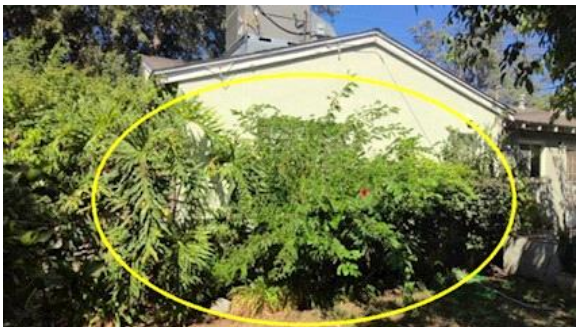
Obstructed access &/or visual of external siding

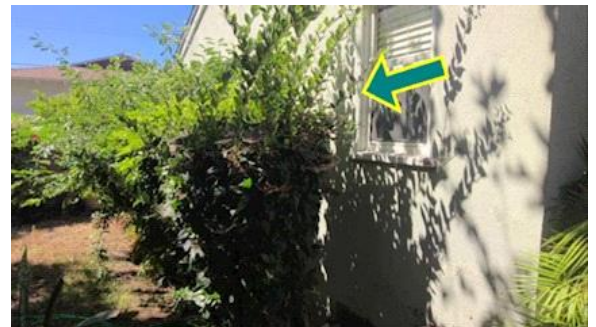
Vegetation in contact with siding

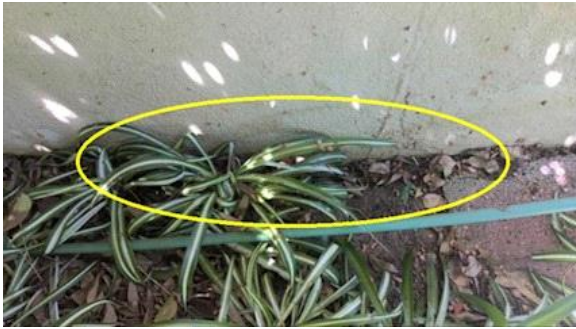
Soil, landscape materials / grading in contact with stucco

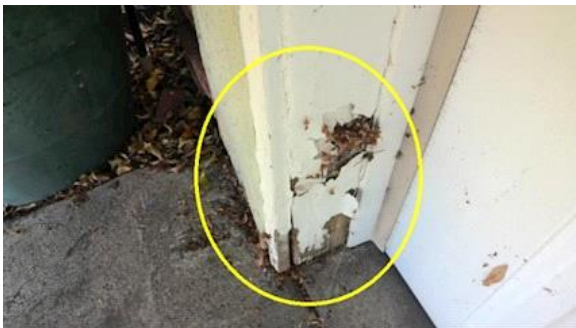
External surfaces in need of servicing, paint and/or sealing

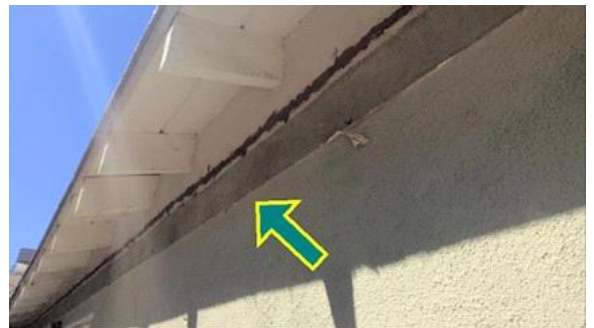
- Stucco observed damaged, blistered, cracked, separating, with holes and/or unsealed penetrations at multiple areas.
- Several areas of wooden trim, fascia and/or siding components present with decayed, rotted or deteriorative conditions.

Altered, penetrated & unsealed stucco surface areas

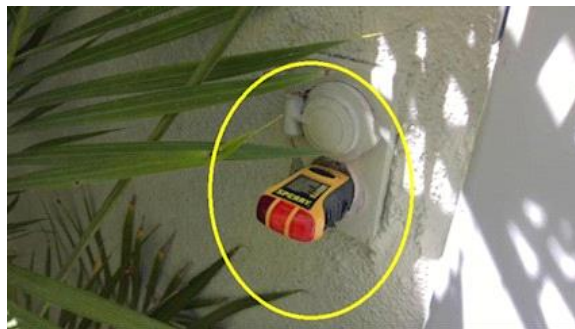
- Weatherproof enclosure(s) missing and/or damaged at external electrical outlet(s). Current industry standards indicate all exterior electrical outlets be encased within industry approved weatherproof devices for additional safety.

- Open ground detected at east wall electrical outlet.
- All exterior lighting unconfirmed at time of inspection due to suspected expired (burnt) and/or missing light bulbs. Recommend all undetectable conditions beyond changing of light bulb(s) be further evaluated by a licensed electrical contractor.

Weatherproof enclosure damaged / Open ground detected

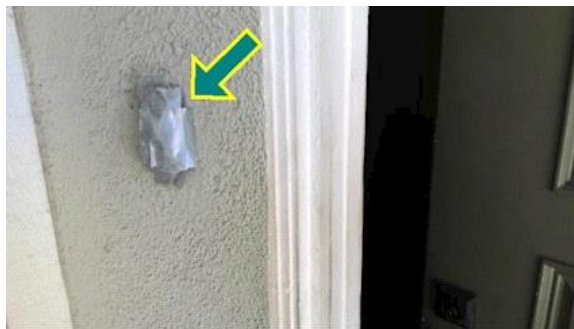
Altered / inoperable (unconfirmed) doorbell

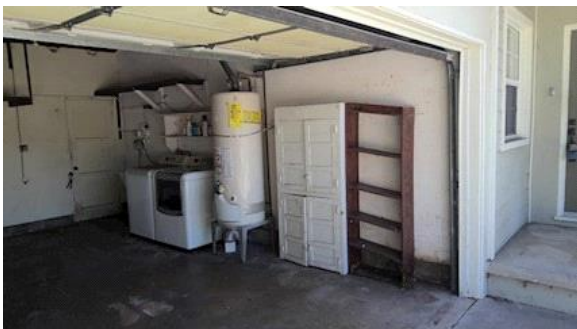
Obstructed / limited interior access & visual inspection

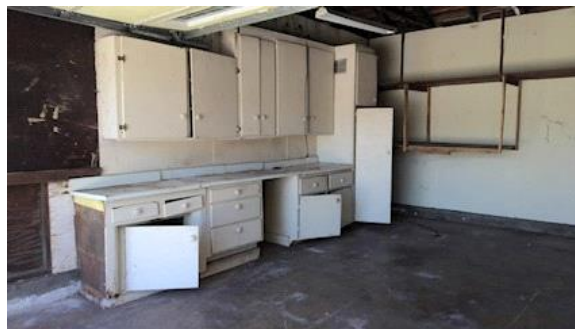
Decayed / damaged built in cabinetry

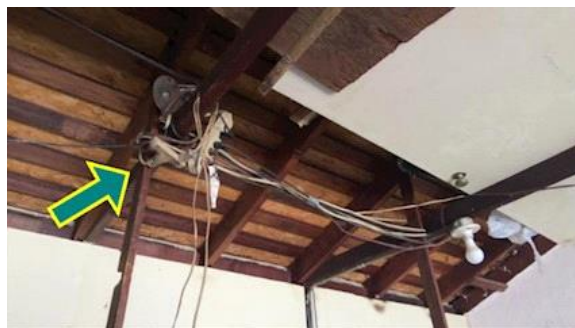
"Mounted" extension cord use

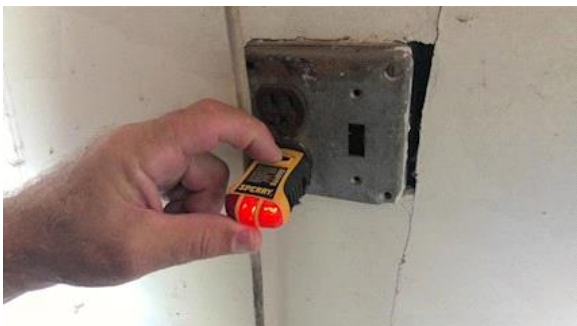
Missing GFCI protection

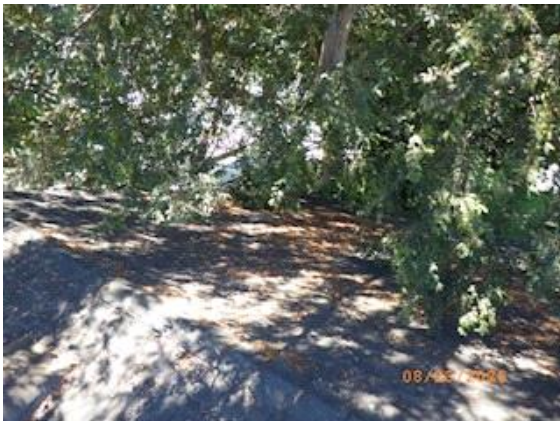
Tree & residual debris in or nearing contact with roof top

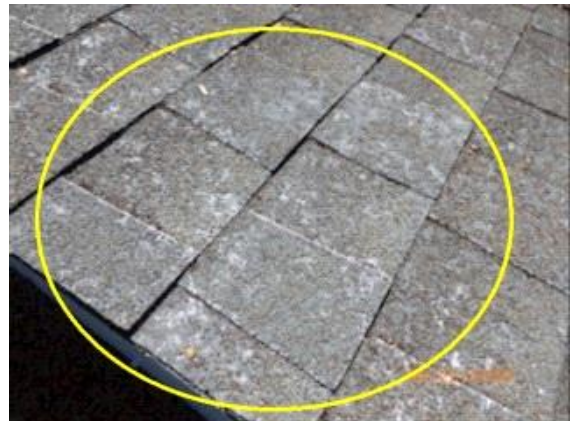
Eroded granular surfaces

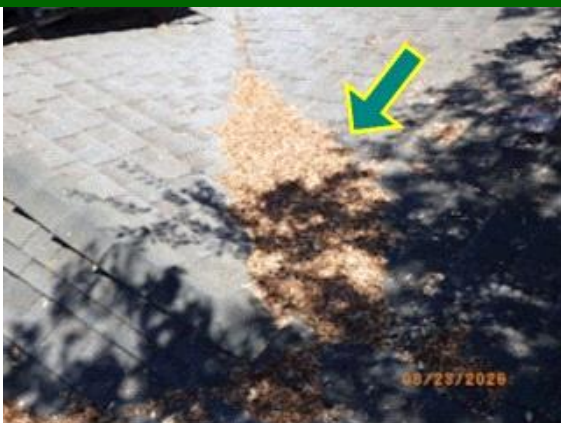
Debris filled valley

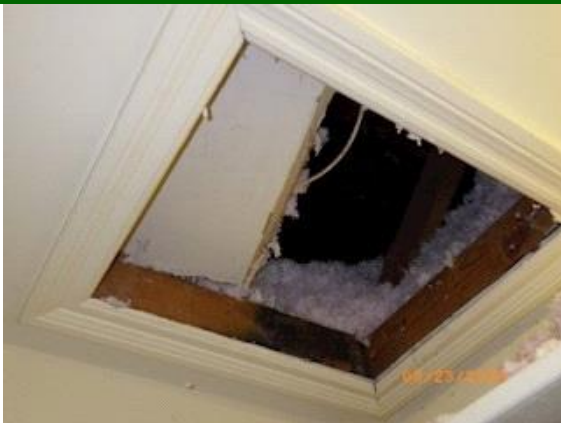
Limited / obstructed interior access

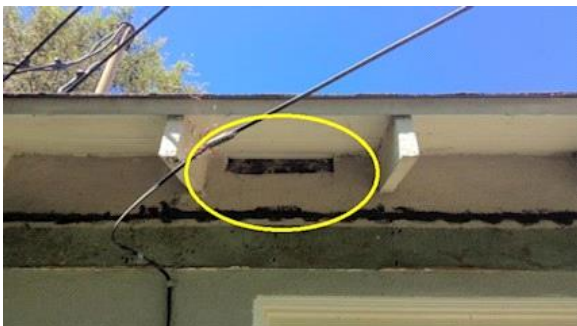
Obstructed soffit vents @ internal attic

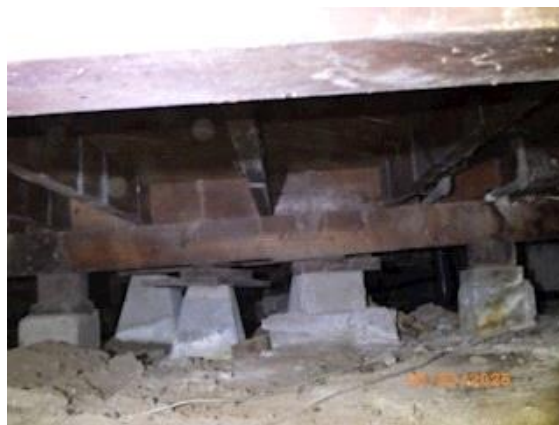
Limited / obstructed interior access & visual inspection

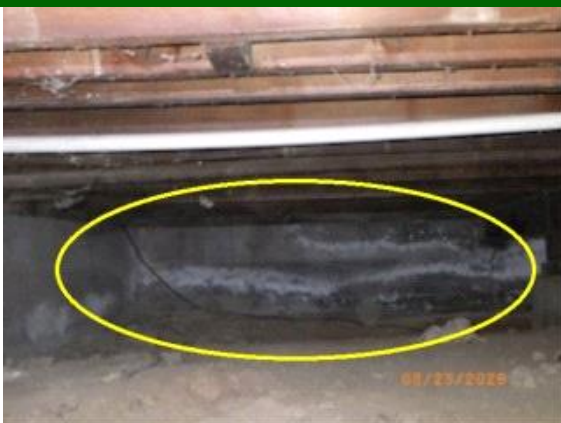
Efflorescence / chalky substance present

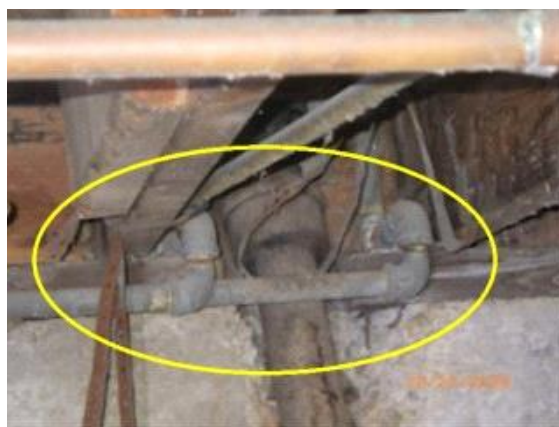
Old galvanized pipe still present

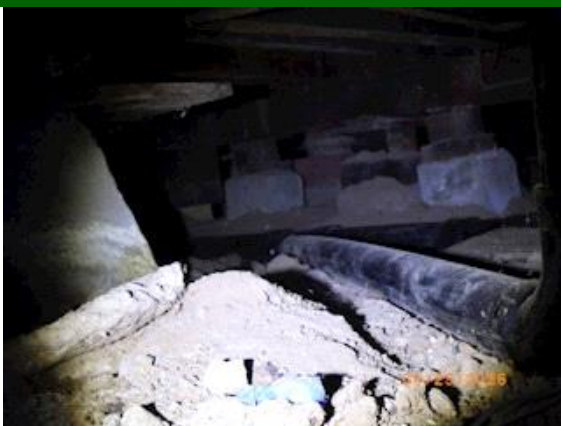
Ex.#1: Limited / obstructed interior access & visual inspection

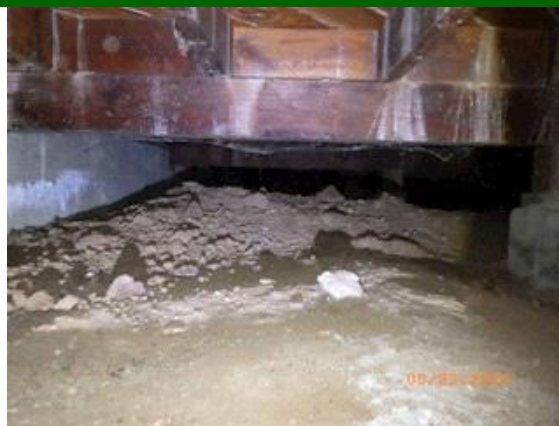
Ex.#2: Limited / obstructed interior access & visual inspection

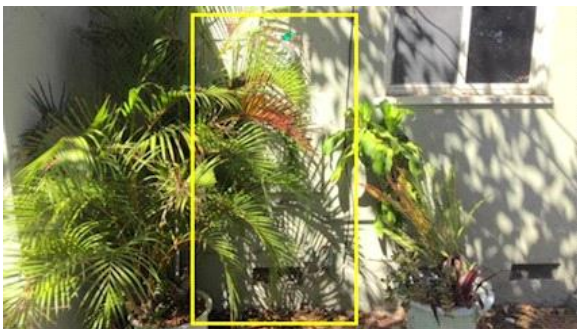
30 x 36 service access obstructed in front of main SE panel box

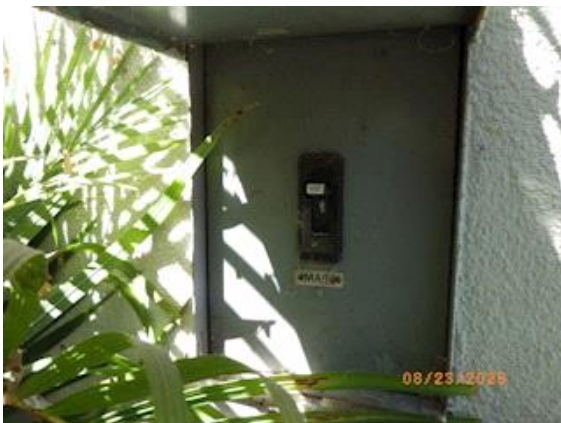
Main disconnect observed secure & intact

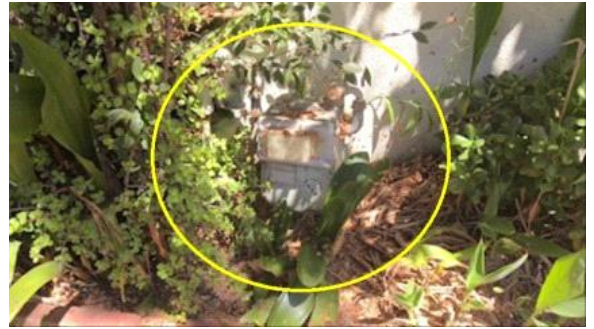
Gas meter intact

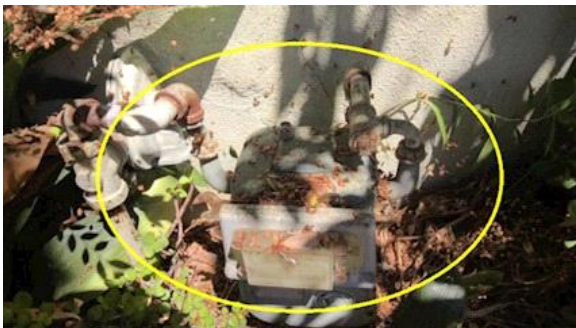
• Gas meter assembly observed with "rusted" pipe and/or pipe fittings, which potentially can lead to gas leaks at impacted connections or fittings overtime. No obvious leaks were detected at the time of inspection.

"Rusted" pipe @ gas meter assembly

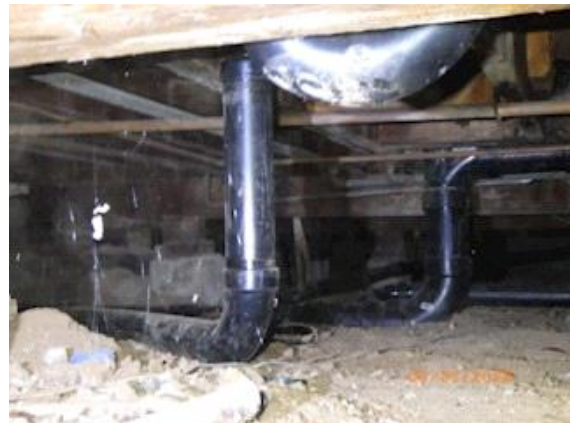
• Observation: Upgraded ABS drain/waste and water-supply piping was observed at visible portions of the plumbing system. No obvious improper fitting configuration was identified within the limited areas observed; however, due to significant crawlspace obstructions and access limitations, complete routing, connections, supports, drainage slope, and overall installation could not be fully evaluated. Concealed or inaccessible conditions remain undetermined. Recommend further evaluation by a qualified plumbing contractor if additional confirmation of the system installation or condition is desired.

Upgraded plumbing observed @ crawlspace areas

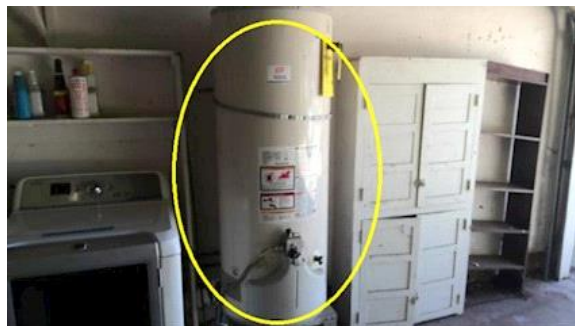
- Improper or unconventional singular strapping present at time of inspection. Plumber's tape typically is not an approved application.
- Proper earthquake strapping not present. Current industry standards require a minimum 2 straps with the lower strap being a minimum of 4 inches above the control box and upper strap within upper third of appliance.

Improper & missing 2nd seismic strapping

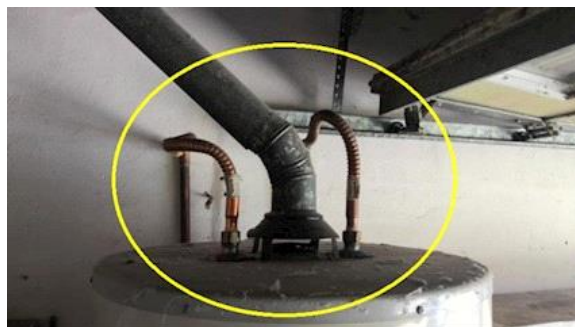
- Insulation not present on both water supply lines. Current industry standards recommend hot and cold pipe be insulated within 5ft of the tank. Recommend licensed plumbing contractor install industry approved insulated product for optimal efficiency.
- Conventional sediment trap / drip leg not present at time of inspection (appears common to region). Sediment trap device creates location for debris or foreign materials to rest and not interfere with conventional gas flow to appliance and drip legs are intended to allow any water vapor within gas supply to not interfere with appliance functionality as well.

- Thermal expansion tank unconfirmed / missing at water heater system. Industry standards since about 2006 indicate a thermal expansion tank be integrated / installed if you have a 'closed-loop system' caused by any kind of check valve or pressure regulating valve installed on your house's water supply line. Note: Various applications, open supply systems and local building authorities can have an impact on requirement standards.

- Exhaust flue pipe improperly secured. Current industry standards indicate sheet metal screws connect all intersecting / connecting joints; screws are not present at all intersections. Recommend licensed contractor install industry approved attachment hardware (ie. sheet metal screws) for additional safety.

Missing insulated wrap @ supply lines, screws @ exhaust flue & expansion tank

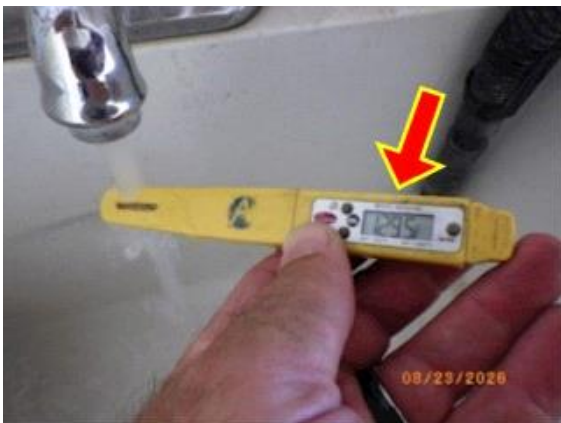
Water temperature exceeds 120 degrees

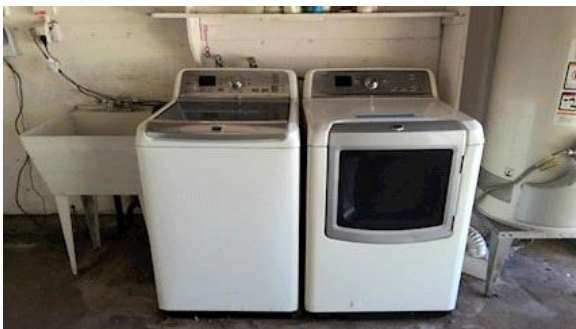
- Confinement of existing laundry area and/or positioning of current laundry machines limited a complete visual inspection or confirmation of all utility hookups, supply, drainage and/or venting by this inspector at the time of inspection. Refer to the General Information - Access & Visibility Limitations section of this report for full details. Further evaluation by a licensed contractor is recommended if additional access or investigation is desired.

Confined Laundry area / Unconfirmed existing machines

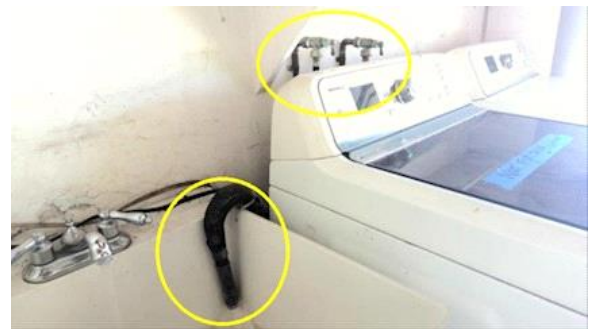
Laundry hookups & laundry tub drainage intact

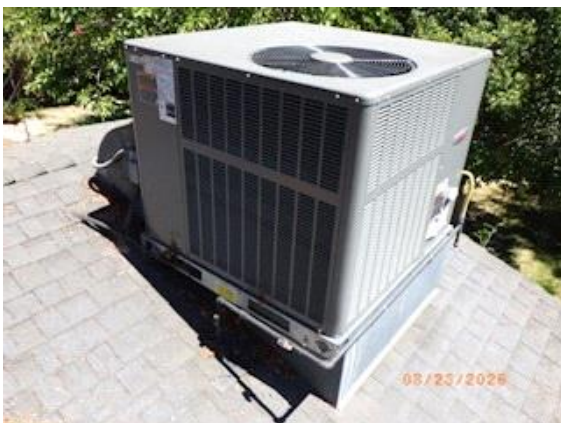
RTU system observed secured & intact

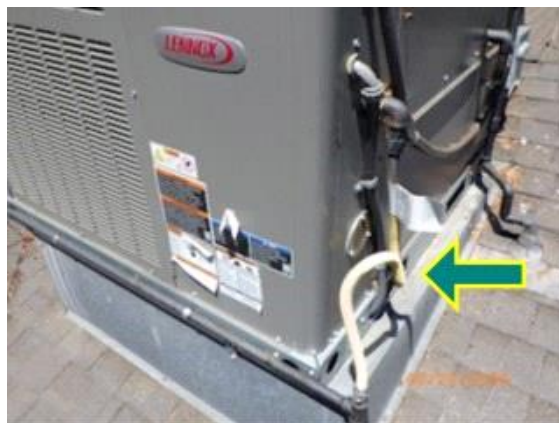
- Note: Corrugated stainless steel tubing (CSST) and/or similar flexible gas piping was observed serving exterior/rooftop equipment. Although CSST is commonly approved for exterior applications when installed in accordance with the specific manufacturer's requirements, prolonged exposure to sunlight, weather, physical damage and other environmental conditions may contribute to deterioration of the protective jacket and/or associated components over time. Installation requirements may also vary based on the CSST manufacturer, product generation and date of installation. The inspection is visual and does not determine concealed routing, bonding, product history or full compliance with manufacturer requirements. Recommend periodically monitoring exposed CSST for deterioration or damage and having questionable, damaged or older installations further evaluated by a qualified licensed plumbing/HVAC contractor.

Observed CSST @ RTU

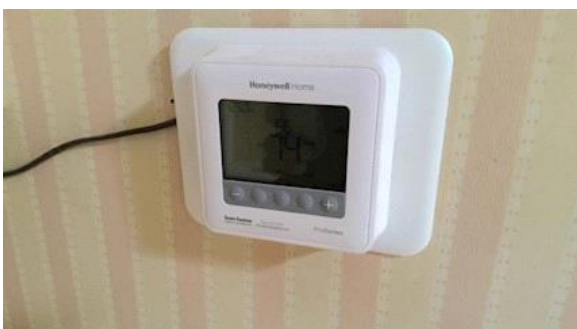
Thermostat(s) intact & observed functional

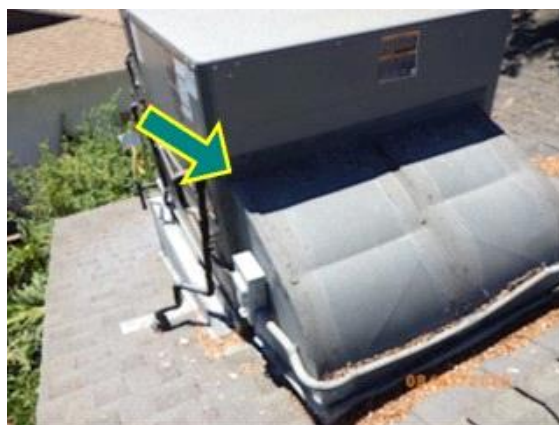
RTU distribution assemblies observed intact

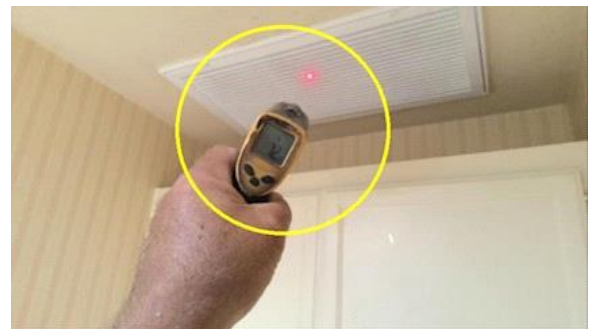
Return temperatures monitored

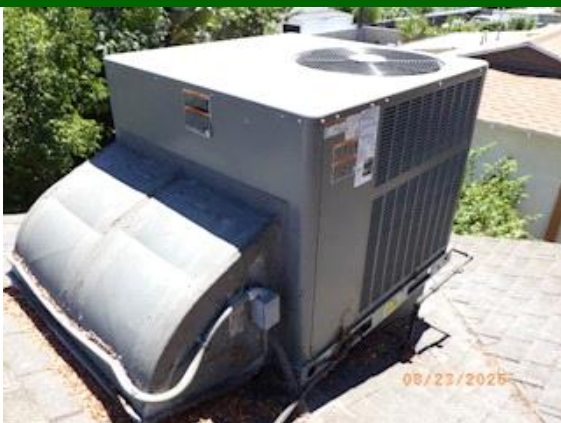
RTU combo system observed intact & functional

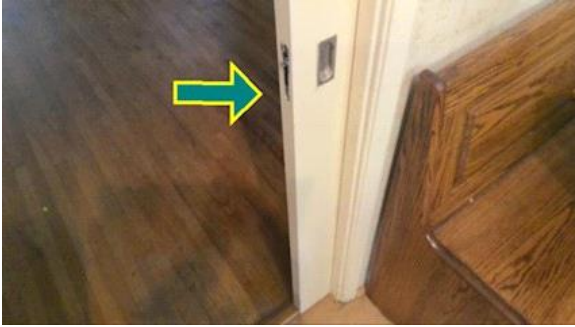
Misaligned / difficult pocket door

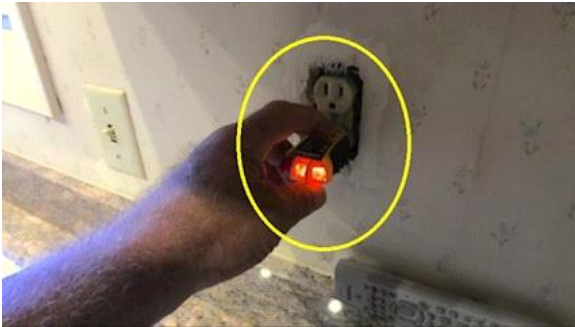
Missing face plate & GFCI protection @ outlet

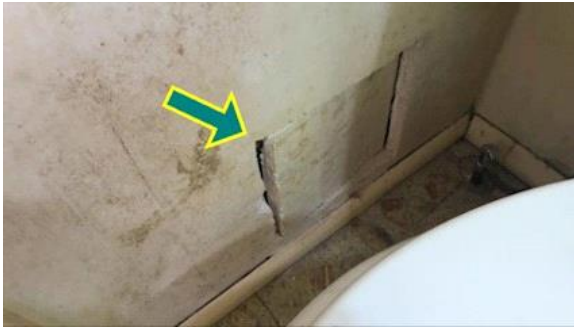
- Damaged, penetrated and/or unpatched wallboard surfaces.
- Delaminated / separating and detached linoleum flooring.
- Loose or unsecured toilet mounting at floor. Specific cause undetermined but condition may or may not be related to mounting bolts, deteriorated flange and/or wax ring under base of toilet.
- Burnt out, unconfirmed ceiling mount light fixture with missing decorative fixture globe.
- Unconfirmed / missing water tight moisture resistant ceiling light fixture above shower stall renders immediate safety concern.

Altered / penetrated wall board

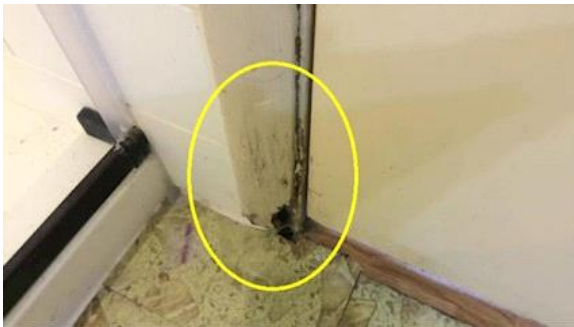
Decayed entry door trim

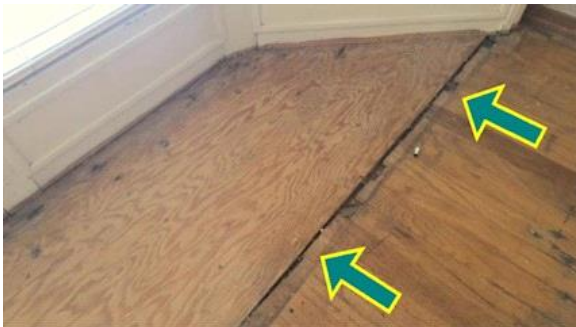
- Detached internal window trim and rotted / decayed window sills at more than one location.
- Rotted, decayed, altered and unfinished internal flooring surfaces at multiple locations.
- Inoperable / unconfirmed light fixture(s) with specific cause undetermined - Condition suspected as being related to burnt out bulb or luminary device.

Altered / unfinished flooring surfaces

Items listed below failed to operate and/or perform its intended function, was structurally deficient, was unsafe or was hazardous at the time of the inspection. Recommend all stated (but not limited to) conditions be further evaluated and repaired within an agreed upon duration of time by licensed contractors of the appropriate trade:

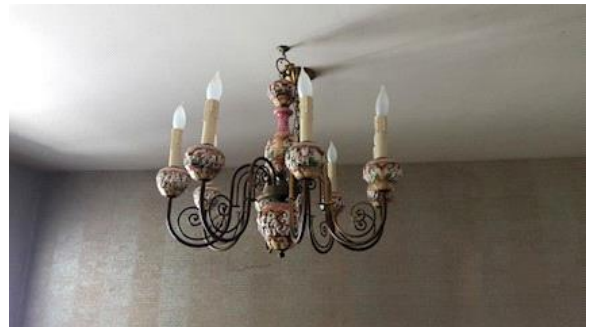
Unconfirmed / inoperable light fixture

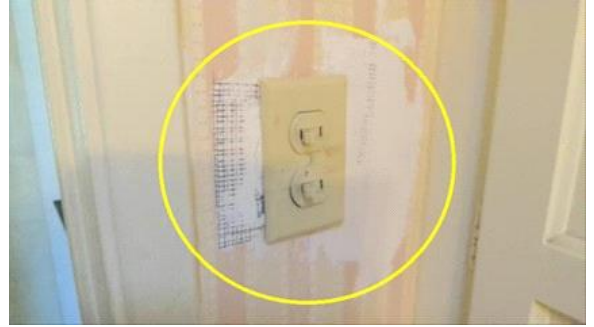
- Inconsistent / unmatched or incomplete drywall patchwork observed at one or more wall or ceiling surface areas.
- Faded, stained and discolored wood flooring surfaces at random locations.
- Unconventional wood flooring patchwork at random locations.
- Dismantled, missing or altered cabinetry latch work at one or more locations.

Incomplete wallboard patching

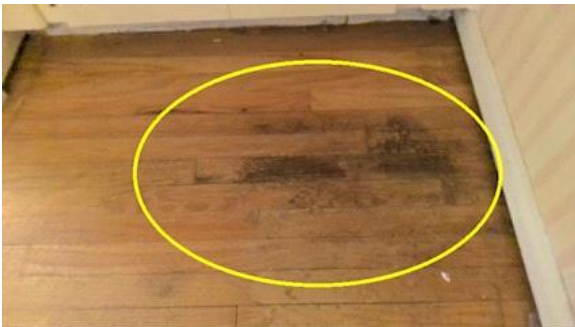
Stained wood flooring

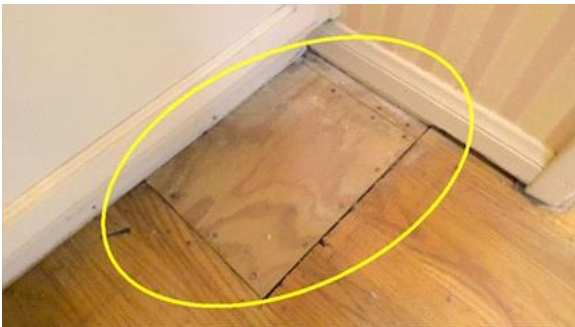
Unfinished flooring patchwork

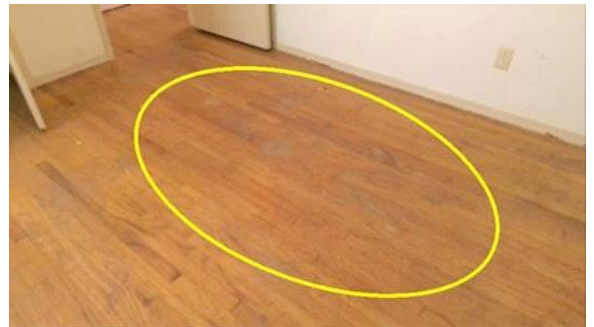
- Cracking conditions observed at various ceiling or wall surfaces with specific cause undetermined but suspected as being related to common seismic activity and settlement within region. Note: Impact on internal structural framing and support was undetermined due to "finish" applications (ie: wall board) obstructing view.
- Marred, gouged and/or unpatched penetrated walls at random perimeter locations.
- See additional comments within Exterior - Windows section of this inspection report for more information.
- Marred / scratched and in need of servicing finish flooring.

Bedroom 2 / Interior view #2 - Scratched, marred wood flooring

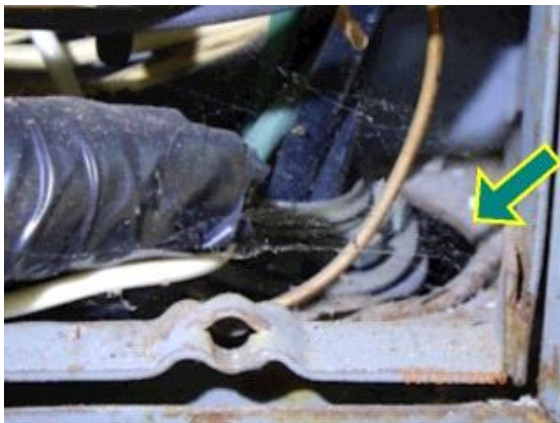
1

Detached / unsecured internal electrical panel box connector
