National Property Inspections

Bettner Trust, 3421 Santa Clara Cir, Costa Mesa, CA, 92626

Wednesday, November 5, 2025

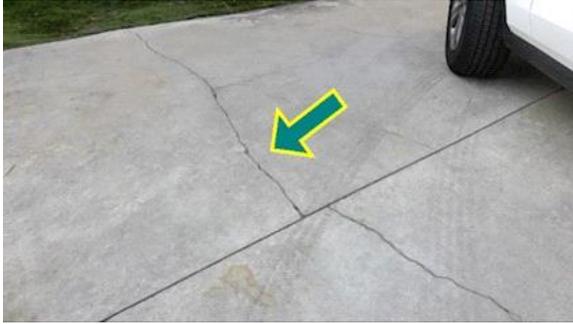
Cracking conditions observed

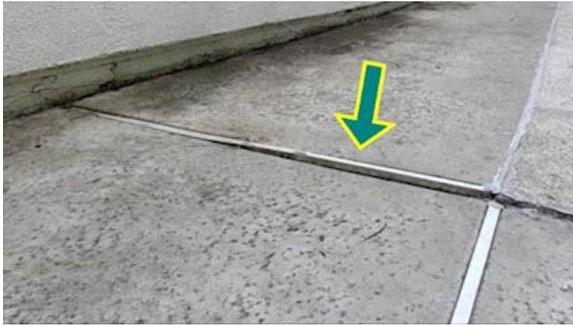
Ex.#1: Unlevel surface(s) / Potential tripping concern

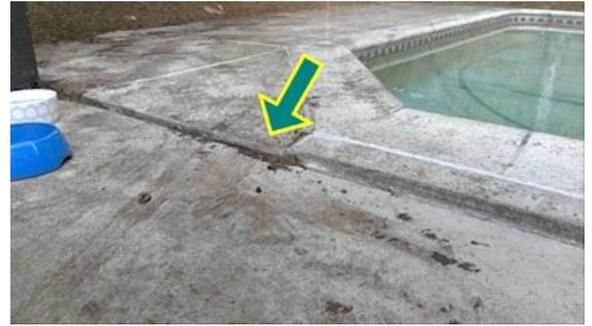
Ex.#2: Unlevel surface(s) / Potential tripping concern

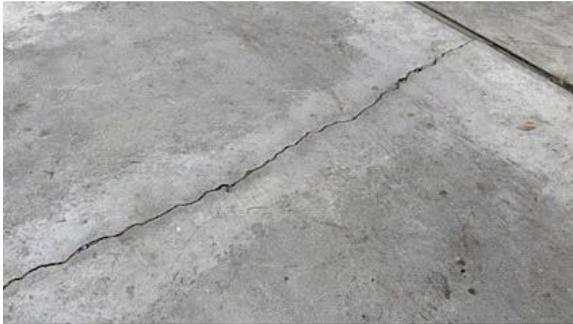
Cracked concrete surfaces

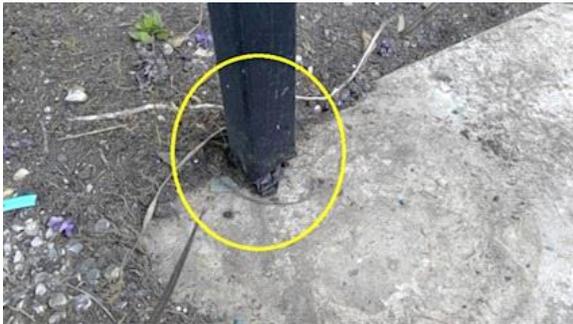
Wood rot / decay conditions @ support posts

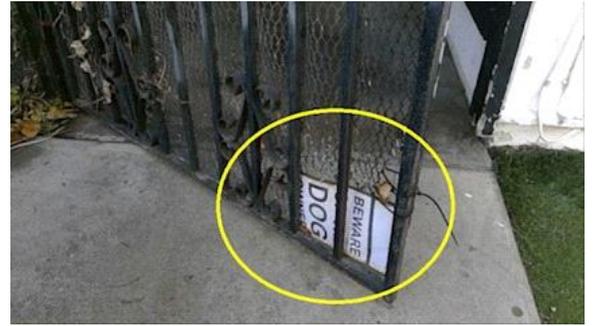
Detached / altered expanded metal @ front gate

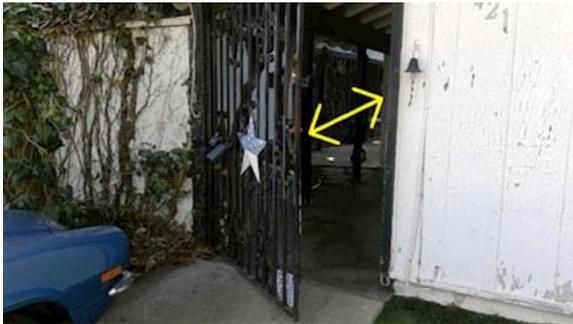
- Side gate swings outward from direct pool access but observed missing any kind of self closing device at the time of inspection. Safety gates by California Health and Safety Section 115923 standards are to have all of the following characteristics:

Self closing / latch device inoperable or missing at direct pool access gate(s)

- (e) An outside surface free of protrusions, cavities, or other physical characteristics that would serve as handholds or footholds that could enable a child below the age of five years to climb over.For additional safety, recommend repair and/or further evaluation by a licensed contractor of the appropriate trades.

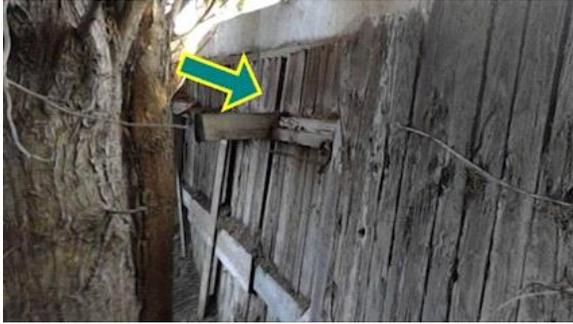
- Damaged, rotted, stained and/or decayed wood planking and/or related installations observed at multiple areas.
- Misaligned, unsecured / detached and/or leaning wood planking or related installations observed at southern fence line.

Leaning / decayed wood fence line

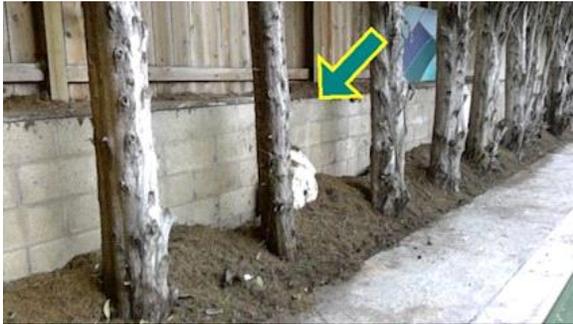
Ex.#1: Retaining wall intact / Unconfirmed - missing weep holes

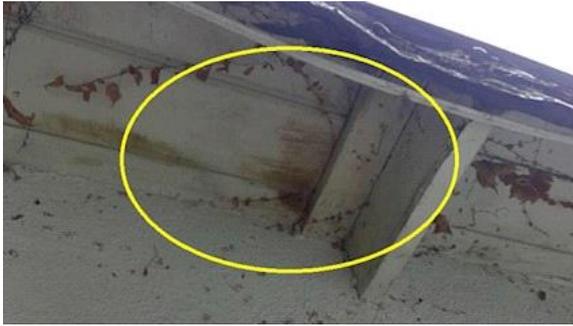
Stained / discolored shiplap, soffit & eave areas

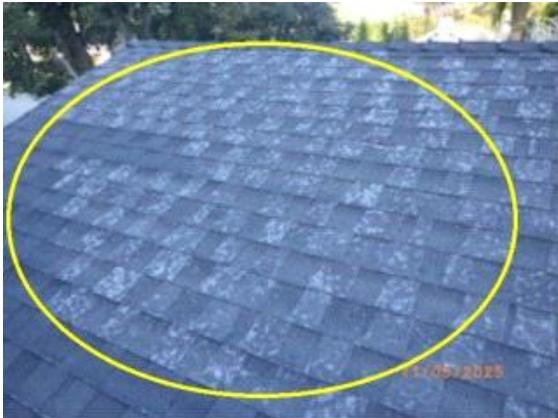
- Granular shingle surface deteriorated, eroding and worn at multiple areas with underlying sub surface material exposed.
- Note: Overall, more than one area of shingle installation appears at the end of its useful life and will likely require replacement and/or repair within near future.

Eroded granular surfaces

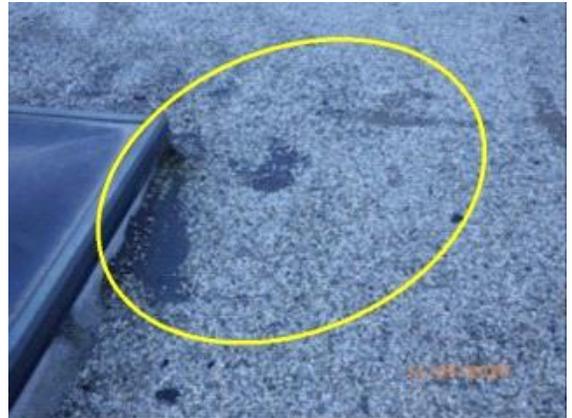
Displaced gravel / Exposed membrane

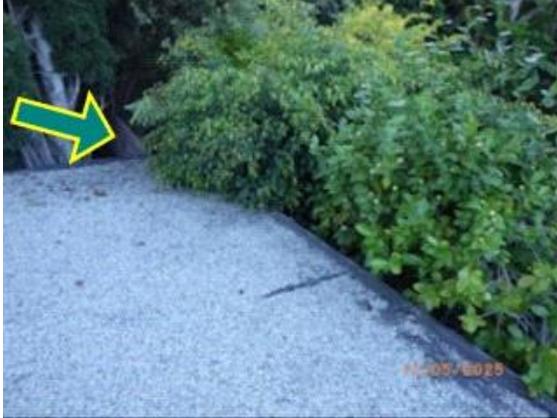
Tree / vegetation in or nearing contact with roof top

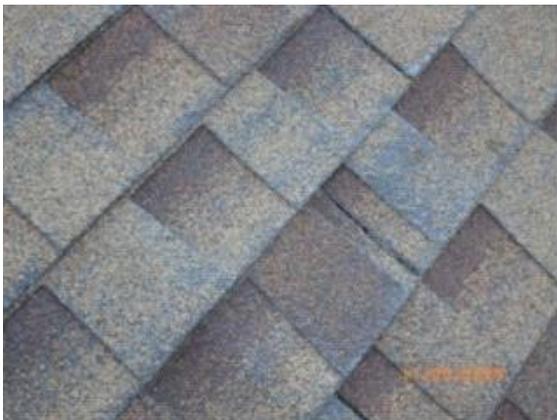
Eroded granular surfaces @ more than one location

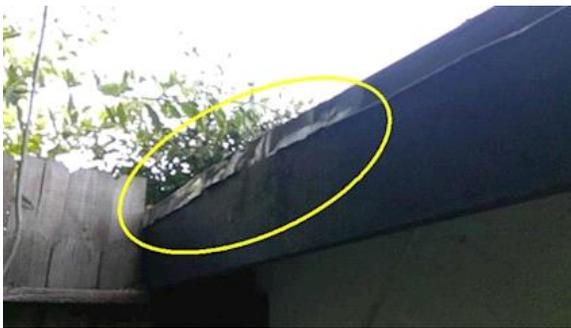
- Damaged / altered drip edge flashing at NW corner.
- Mastic seal on roof jack vents observed deteriorated and/or beginning to crack at various locations.
- Affected assemblies are common areas for possible moisture intrusion.

Damaged / altered drip edge flashing

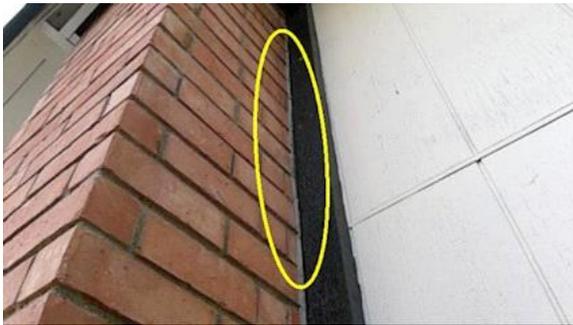
Ex.#1: Separated / deteriorating caulk seam @ flashing assembly

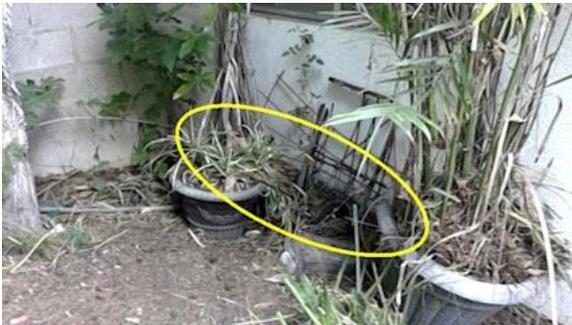
Soil in contact with stucco siding

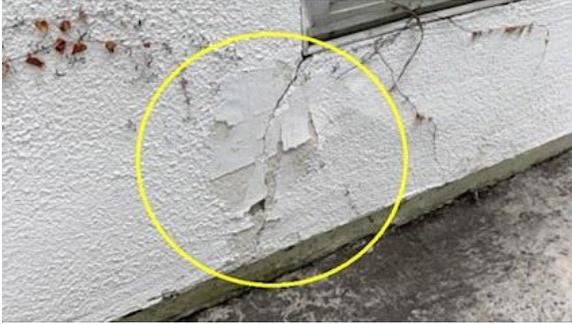
- Siding and/or trim deteriorated and in need of servicing, caulk and painting at multiple locations.
- Electrical circuitry observed with exposed romex and/or unknown wire configurations attached to exterior surface(s) at one or more locations. Current industry standards indicate electrical installations whereas subject to physical damage shall be protected by rigid metal conduit, intermediate metal conduit, electrical metal tubing, Schedule 80 PVC rigid nonmetallic conduit or other approved means.

External surfaces in need of servicing, paint and/or sealing

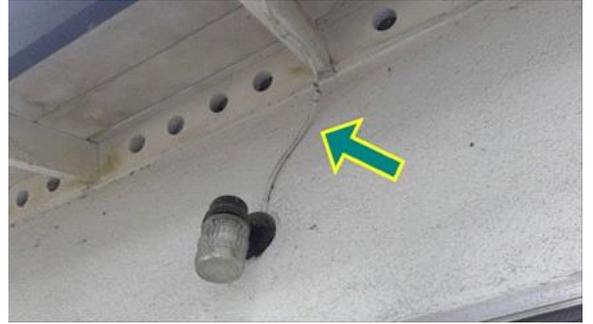
Exposed romex @ light fixture

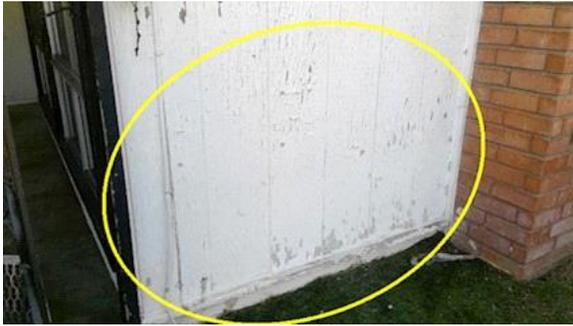
External surfaces in need of servicing, paint and/or sealing

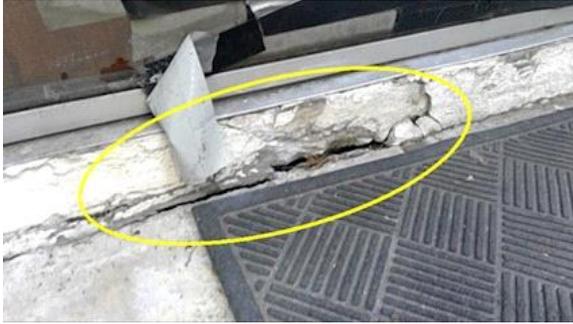
- Spalling, damaged and/or penetrated stucco surfaces below sliding egress thresholds - Potential moisture and/or environmental intrusions area.
- Decayed and/or eroding metal threshold installation at one or more sliding egress thresholds.

Penetrated / eroding stucco @ threshold

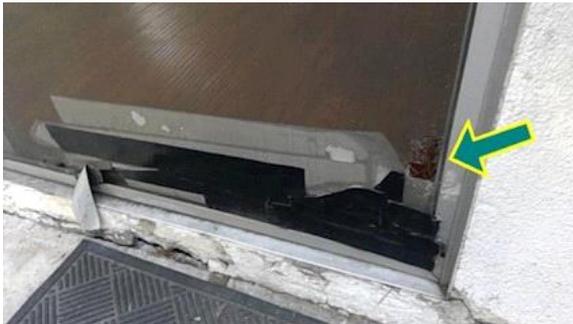
Altered / torn screen door applications

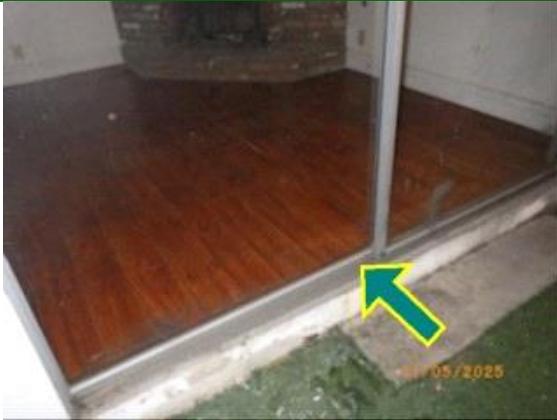
• Note: Current building standards indicate safety (tempered) glazing in certain hazardous locations where glass may be subject to human impact. These areas typically include glazing with an exposed surface area greater than 9 square feet, a bottom edge less than 18 inches above the floor, a top edge greater than 36 inches above the floor, and within 36 inches horizontally of a walking surface or doorway. At the time of inspection, the presence of tempered or safety-labeled glazing at window or fixed-glass panels adjacent to one or more sliding door assemblies could not be confirmed. The observed installations appear consistent with the property's original design and period of construction. For enhanced safety, clients may wish to consult a qualified glazing contractor to confirm the presence and type of safety glazing where required. If unconfirmed, adhesive safety film or other approved protective applications are available to provide additional impact resistance.

Unconfirmed safety glass @ courtyard egress

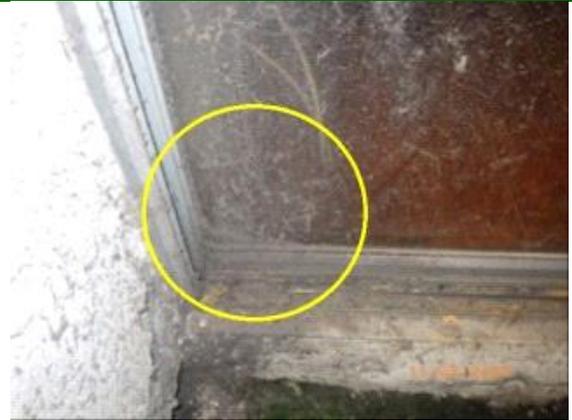
Typical safety glass "bug" locale obstructed

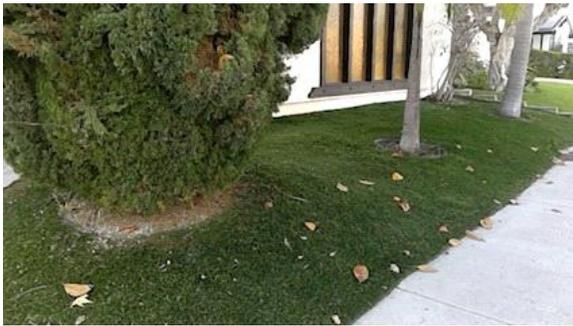
- Additional Note: More than one large tree present at subject property footprint may or may not have impact on foundation system. This inspector was unable to identify any specific concerns at the time of inspection. Recommend monitoring all related installations on a regular scheduled basis for future developments and/or recommend all client concerns be further evaluated by a licensed contractor of the appropriate trade.

Example: Tree root proximity to foundation

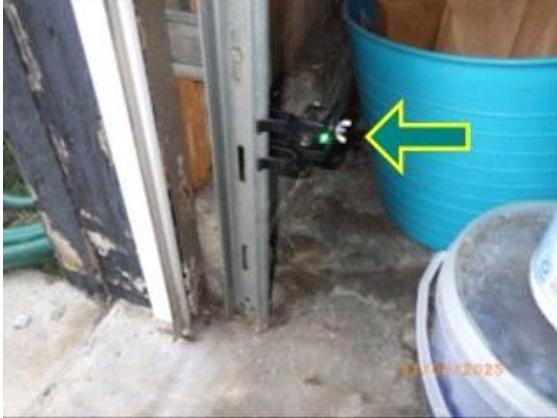
Excessive mounting height @ Laser safety device

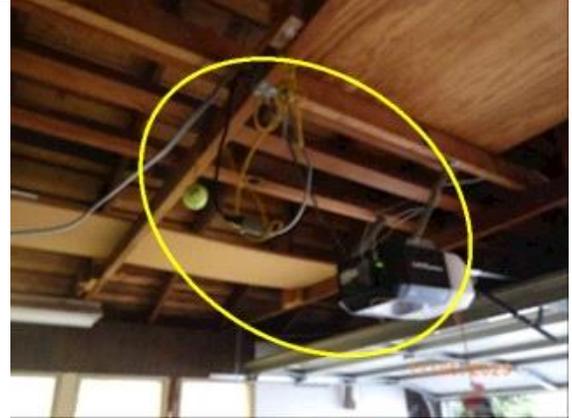
- Garage door opener improperly connected to electrical source. Extension cords are not an approved permanent circuit and are meant to be used on a temporary basis. Recommend licensed electrician hard wire receptacle close to opener for direct access to plug opener into.
- Note: Height of laser emergency stop device at garage door track assembly suspect as above recommended standards at the time of inspection rendering safety concern for this inspector. Typically industry standards recommend installation be approximately 6 inches from floor. Current installation exceeds industry standard. For additional safety, recommend licensed contractor adjust installation to meet current industry standards.

Extension cord power supply to garage door opener

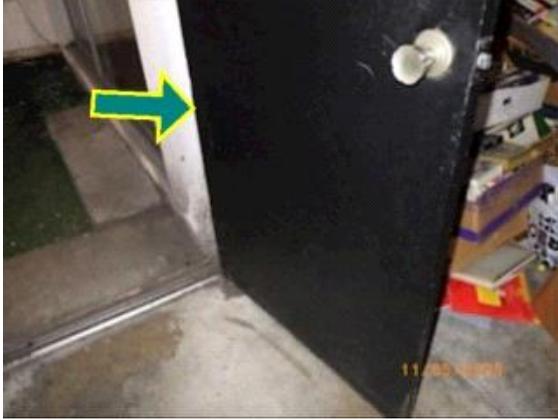
- Note: Pedestrian door is hollow core installation. Exterior doors for additional safety are typically recommended to be solid core.

Hollow-core door suspected

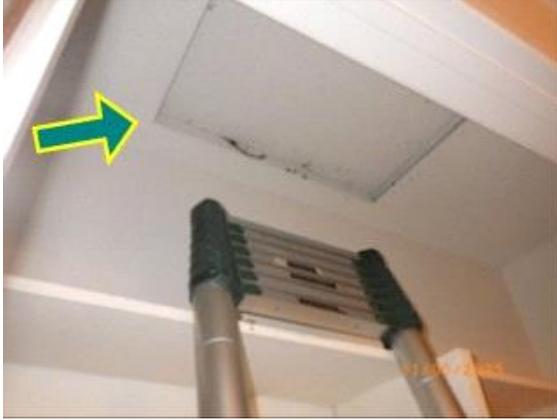
- Vaulted ceilings present, rendering limited internal attic space and obstructed visual inspections of all structural and/or mechanical components typically installed within conventional attic areas. In addition, interior availability of readily accessible attic access and space was limited, obstructed by framing, insulation, HVAC ductwork and/or missing a stable platform surface for this inspector to safely traverse as well. Note: Industry standards of practice indicate the inspector is not required to enter any attic / crawlspace area that is not readily accessible or where entry could cause damage or pose a hazard to the inspector. Recommend all undetected conditions and/or client concerns be further evaluated by a licensed contractor of the appropriate trade.

Limited / obstructed attic access

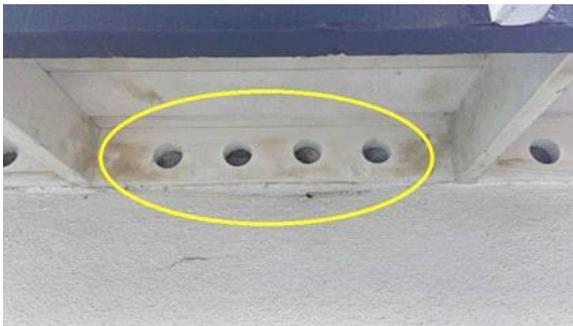
- Soffit ventilation blocked by insulation at more than one location rendering concern for premature deteriorative conditions to occur due to excessive heat within the attic area. Note: Attic interior temperature range is recommended to not exceed 100 degrees. Recommend removing insulation at all impacted locations (by a licensed contractor of the appropriate trade) for optimal air flow, efficiency and to prevent premature deterioration of roofing materials, related to excessive heat from occurring.

Obstructed soffit vents @ internal attic

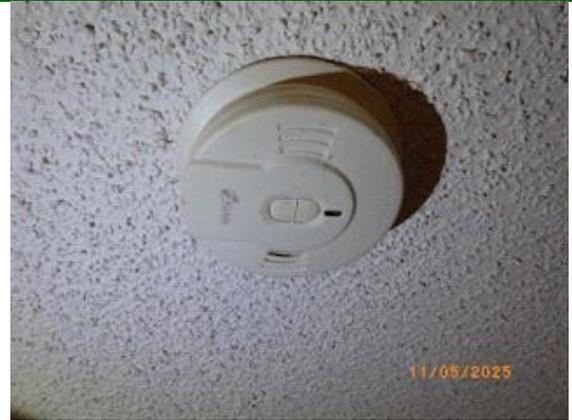
Singular unlabeled smoke alarm

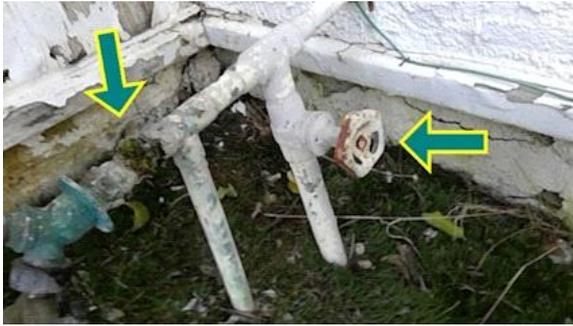
Water main shutoff intact / Corroded plumbing assembly

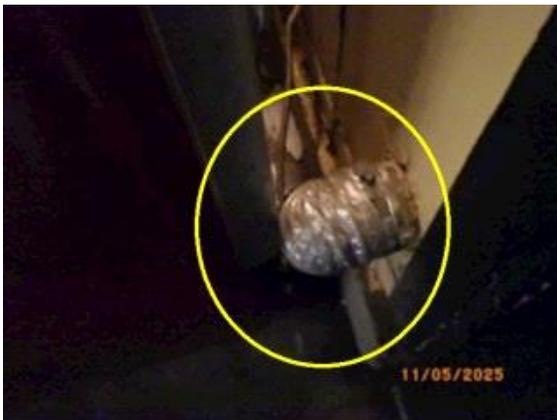
- Antiquated material / installation present at dryer exhaust duct.

Antiquated Dryer exhaust material

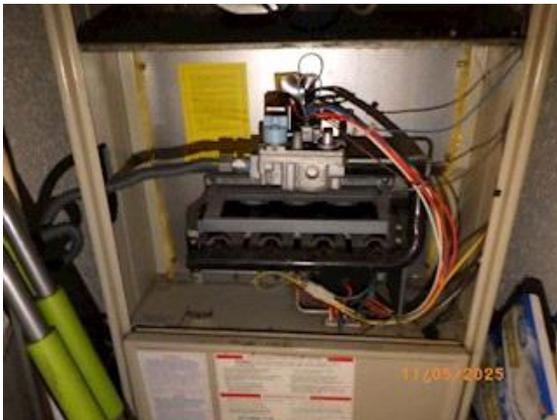
Observed internal FAU components

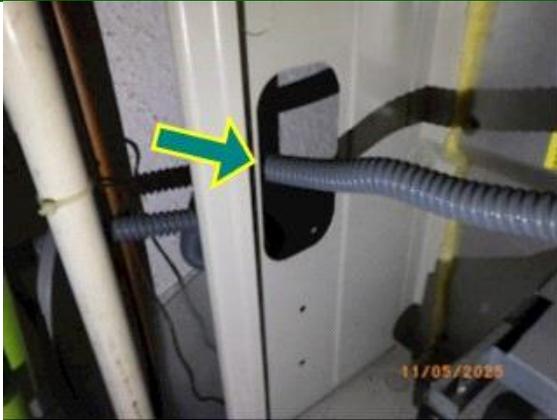
Unprotected CSST / Flexible gas supply passing through cabinet wall

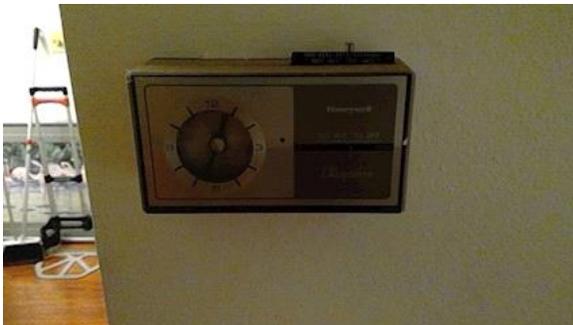
Unconfirmed thermostat

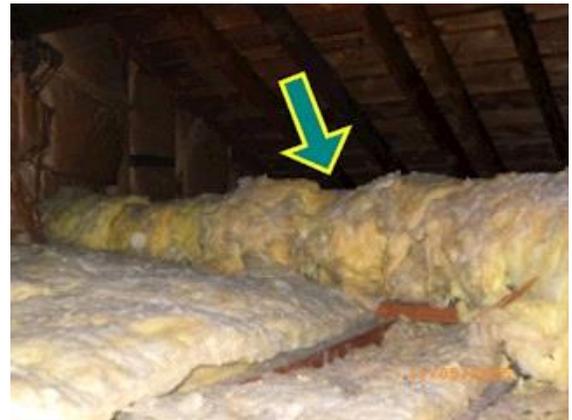
- Limited access within attic area prevented a complete visual inspection of the entire heating and AC distribution (ductwork) systems by this inspector. Note: Visually available ductwork assemblies depicted typical conditions for age of property and overall installation at the time of inspection. Recommend monitoring on a regular scheduled basis for further developments upon which time all conditions be further evaluated by a licensed HVAC contractor.
- Comments stated above within Heating section pertaining to inaccessible, inactive or unconfirmed status apply to this section of the inspection report as well. A complete visual of the entire distribution related assemblies or components was unconfirmed at the time of inspection. Recommend all undetectable conditions be further evaluated by a licensed HVAC contractor prior to the close of Escrow.

Ducting assemblies intact / Limited visual & accessibility

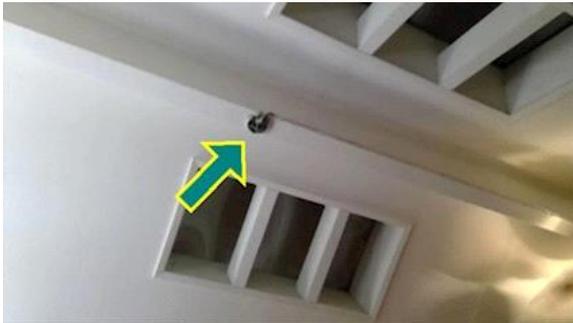
Exposed junction box @ ridge beam

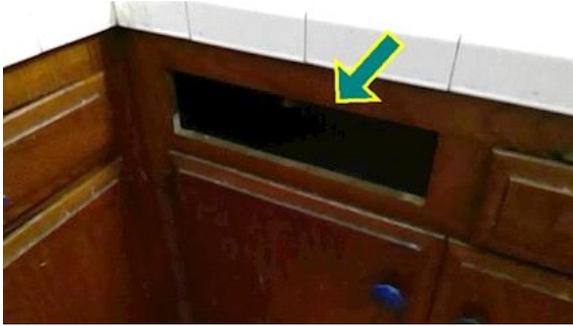
Dismantled / missing base cabinet components

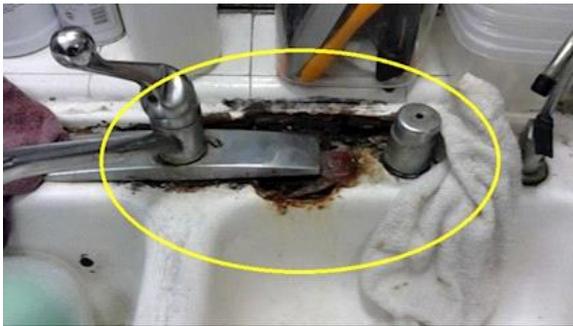
Rusted / corroded basin surfaces

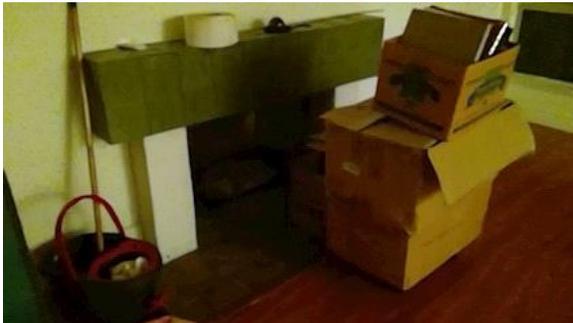
- Note: Current industry standards recommend glass enclosures for additional safety. Glass not present at time of inspection. Recommend all upgrading and/or all altering of installation(s) be completed by a licensed contractor of the appropriate trade.

- Additional Note: Personal belongings obstructed access and visual inspection of fireplace at the time of inspection. Physically moving personal or decorative items was not performed and is beyond the scope of this readily accessible visual inspection process. Recommend all undetected conditions and/or client concerns be further evaluated by a licensed chimney sweep contractor.

Missing glass enclosure / Obstructed access

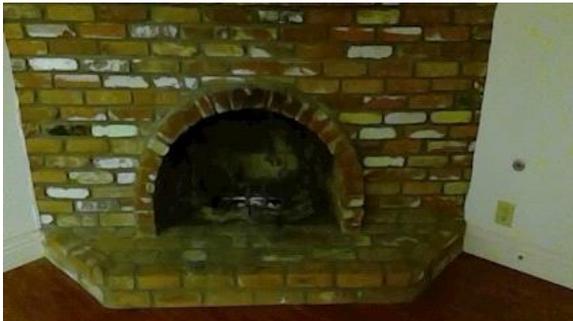
• Note: Current industry standards recommend glass enclosures for additional safety. Glass not present at time of inspection. Recommend all upgrading and/or all altering of installation(s) be completed by a licensed contractor of the appropriate trade.

Missing glass enclosure

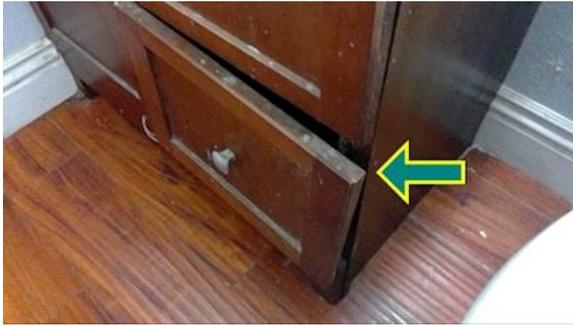
- Burnt out, unconfirmed and/or inoperable light fixture(s)
- Misaligned / detached base cabinet drawer.
- Delaminated mirror conditions at medicine cabinet.
- Detached / dismantled bathtub stopper assembly

Misaligned base cabinet drawer

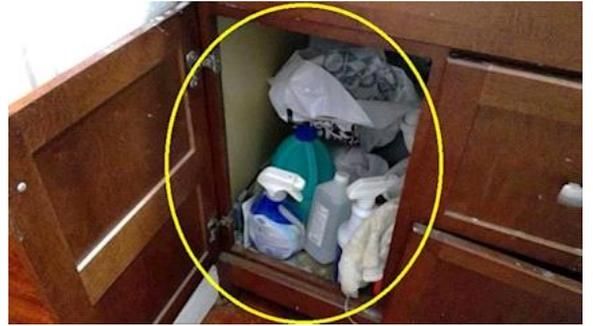
- Note: Plumbing systems and/or associated components typically located below the sink were obstructed by personal items at the time of inspection. Conditions rendered an incomplete visual inspection by this inspector. Recommend all undetectable conditions be further evaluated by licensed contractors of the appropriate trade once area is cleared and accessible.

Limited / obstructed visual below sink(s)

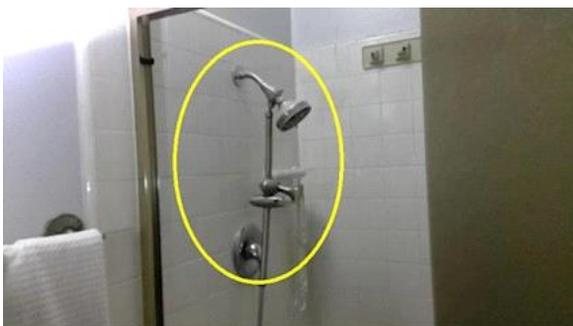
- Detached / unsecured faucet assembly.
- Loose or unsecured toilet mounting at floor. Specific cause undetermined but condition may or may not be related to mounting bolts, deteriorated flange and/or wax ring under base of toilet.
- Leaking / unsecured shower faucet assemblies.

Leaking / unsecured shower faucet assembly

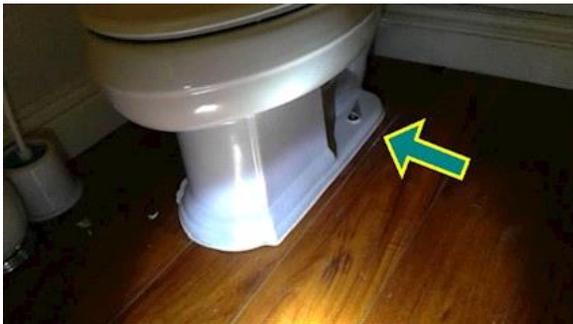
Loose toilet at floor mount

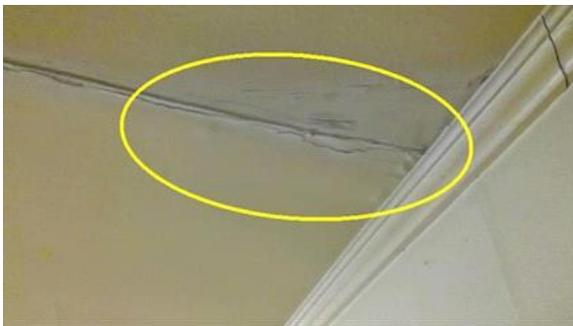
- Altered, stained and decayed ceiling surfaces at north side of room.
- Unconventional / exposed wiring at bath area ceiling fan assembly.

Stained / decayed ceiling

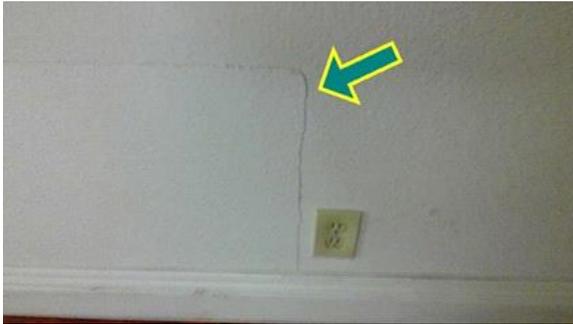
- Cracking conditions observed at various ceiling or wall surfaces with specific cause undetermined but suspected as being related to common seismic activity and settlement within region. Note: Impact on internal structural framing and support was undetermined due to "finish" applications (ie: wall board) obstructing view.
- See additional comments within Exterior - Doors section of this inspection report for more information.
- Delaminated, marred and gouged finish flooring surfaces at more than one location.
- Wall mount AC unplugged and with altered surface conditions.

Cracked wall surfaces

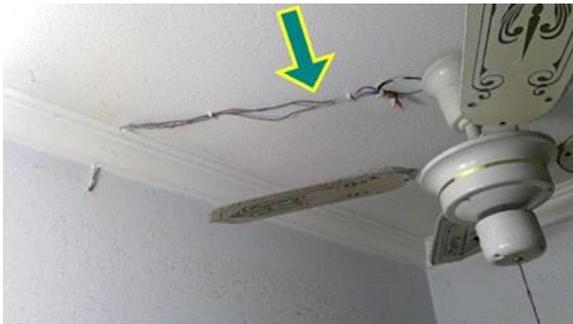
Unconventional wiring @ ceiling fan

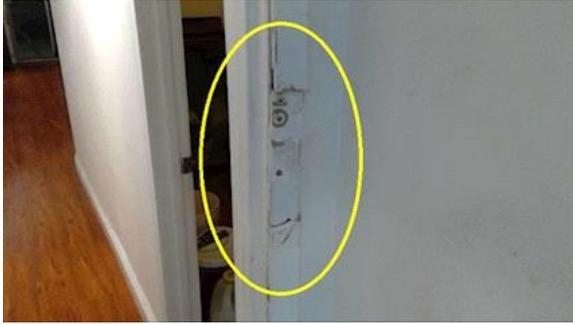
- Altered / damaged bedroom #3 casement trim at entry door.

Altered / damaged casement trim

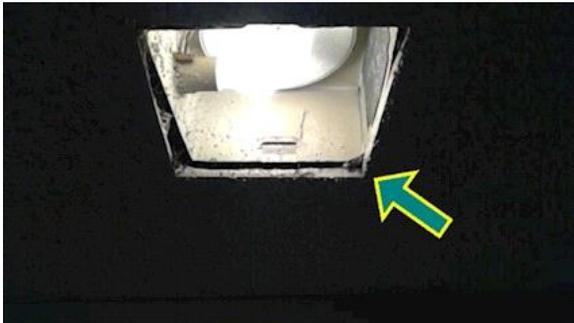
- Missing one or more ceiling light fixture trim kit assemblies.

Missing trim kits @ ceiling lights

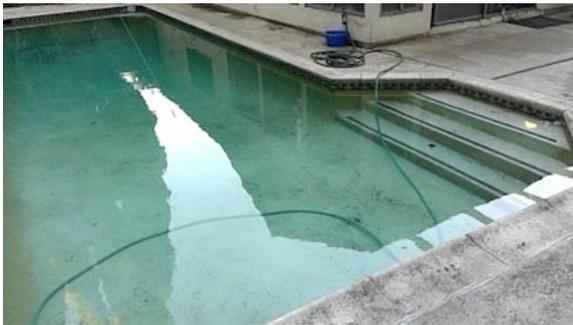
- Multiple areas of discoloration and staining observed within the plaster surface of the swimming pool. Unbalanced water chemistry can have a adverse effect on plaster installations.

Discoloration @ pool water / Potential unbalanced pool chemicals

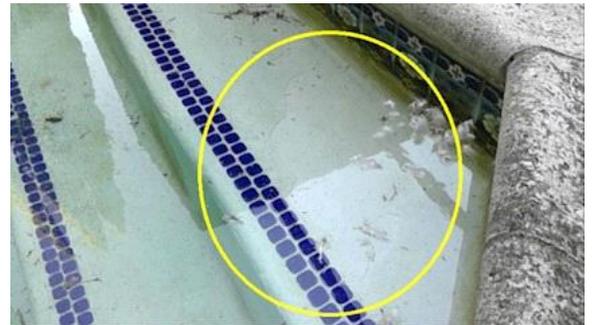
Blistered internal pool plaster @ steps

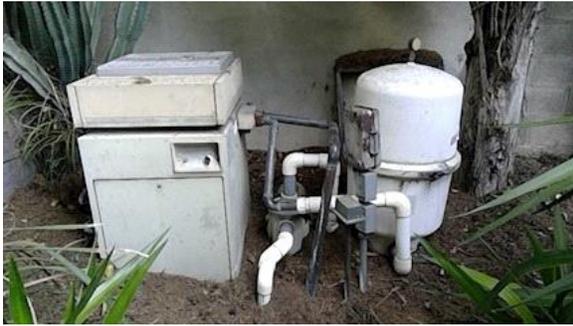
Overview of pool / spa - Area covered in landscape debris

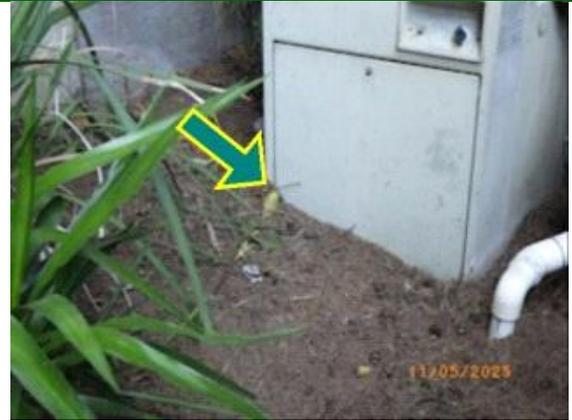
Obstructed service access @ unconfirmed heater

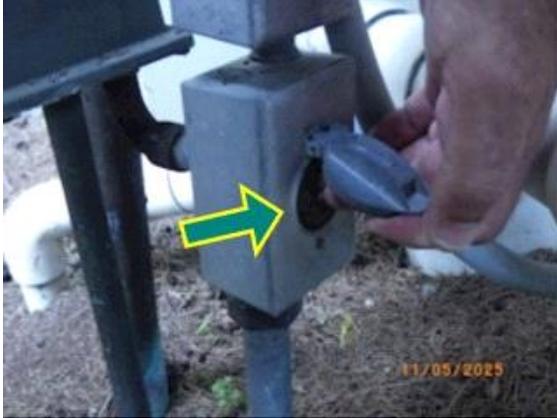
Suspected inoperable pool light switch

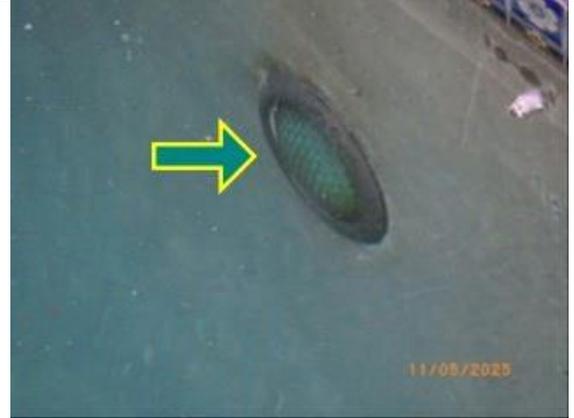
Unconfirmed / inoperable pool light
