# National Property Inspections

Randy Shaver - Trustee, 12942 Yorba Street, Santa Ana, CA, 92705

Inspection Date:  
08/23/2026

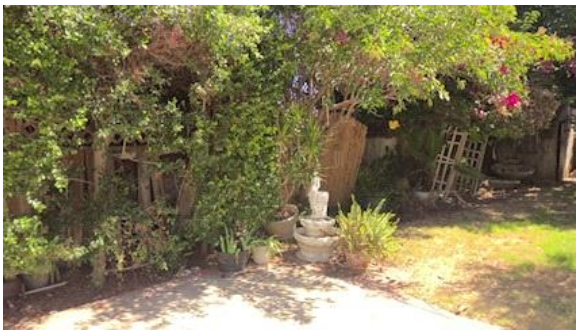
Obstructed visual / limited access

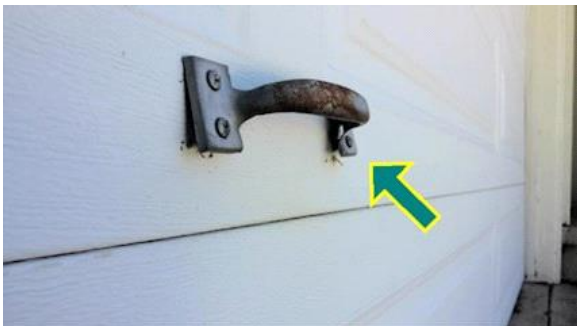
- External handle assembly observed partially detached and loose.

Detached / loose handle

Items listed below failed to operate and/or perform its intended function, was structurally deficient, was unsafe or was hazardous at the time of the inspection. Recommend all stated (but not limited to) conditions be further evaluated and repaired within an agreed upon duration of time by licensed contractors of the appropriate trade:

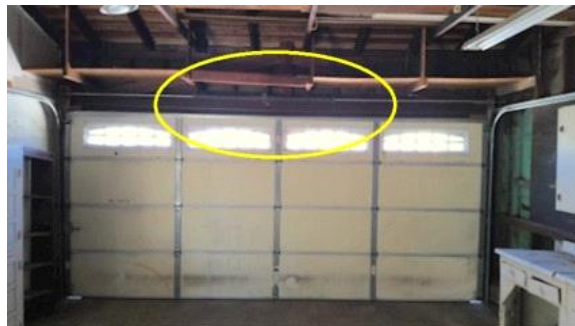
- No electronic garage door opener or manual emergency reverse system was present at the time of inspection. This condition may pose a safety concern, as the door could close abruptly without resistance or warning. Current industry standards recommend garage door systems include an automatic reversal mechanism and battery backup for enhanced safety. Recommend further evaluation and upgrade, if needed, by a licensed garage door contractor to meet current safety practices.

No electronic opener present

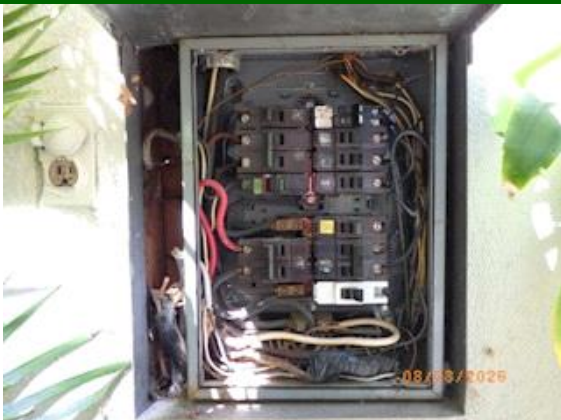
Internal connections & components view

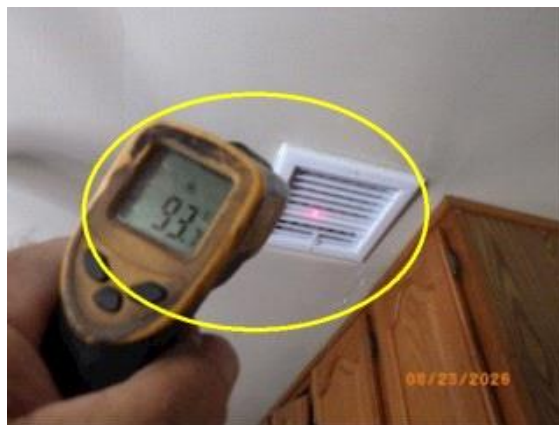
Distribution temperatures monitored

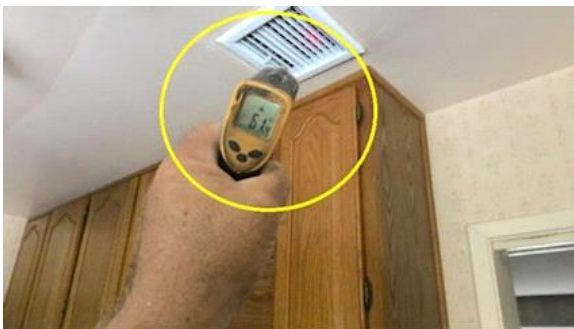
Distribution temperatures monitored

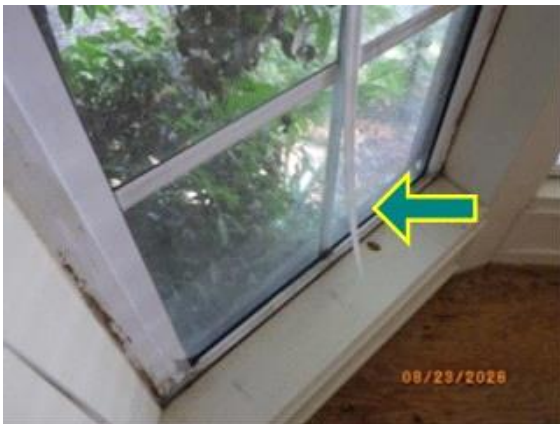
- Detached internal window trim and rotted / decayed window sills at more than one location.
- Rotted, decayed, altered and unfinished internal flooring surfaces at multiple locations.
- Inoperable / unconfirmed light fixture(s) with specific cause undetermined - Condition suspected as being related to burnt out bulb or luminary device.

Detached window trim assemblies

Items listed below failed to operate and/or perform its intended function, was structurally deficient, was unsafe or was hazardous at the time of the inspection. Recommend all stated (but not limited to) conditions be further evaluated and repaired within an agreed upon duration of time by licensed contractors of the appropriate trade:

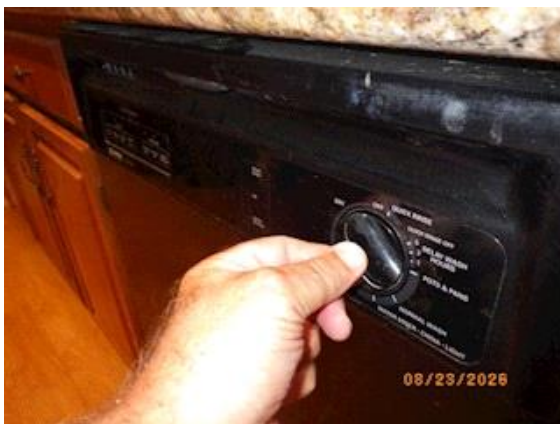
7

Unconfirmed dishwasher appliance

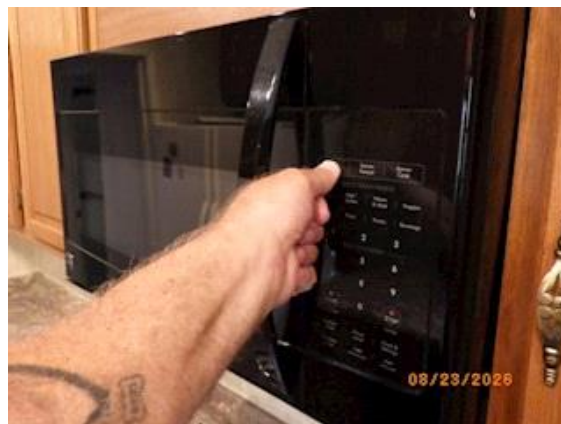
8

Unconfirmed microwave appliance
